Design and Operations Report Silvercreek Solar Park

Report No.: 70287
28 pages, 5 Appendices

Date: November 30, 2012

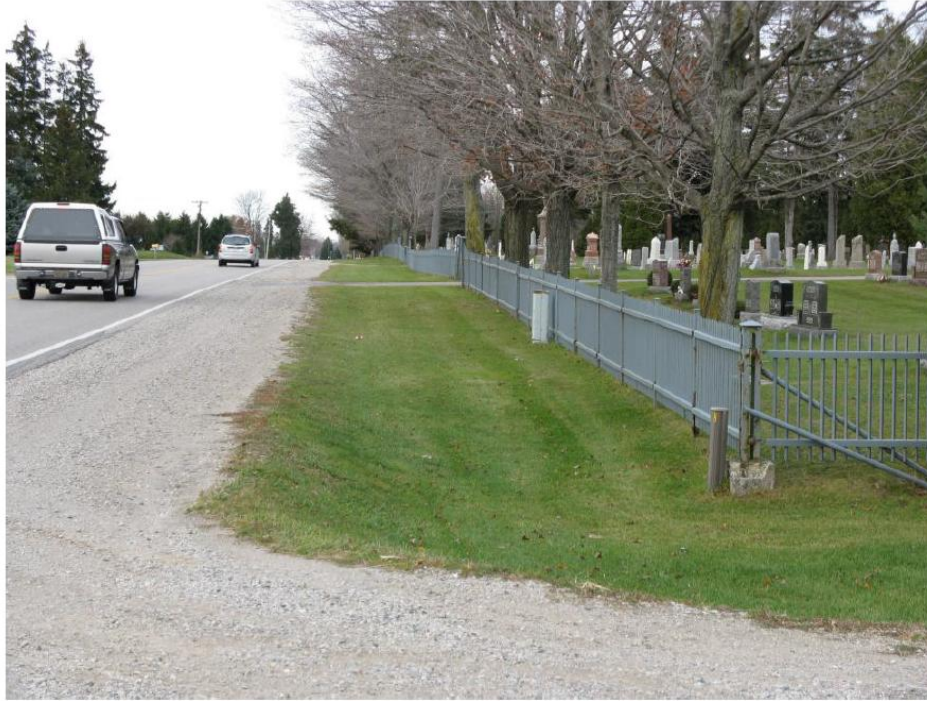
Image 16: Location of transmission line on the east side of Imperial Road, adjacent to cemetery, looking north (note ditching, fill slopes, telephone cable)

Along the east side of Imperial Road, within the municipal road allowance the area has experienced significant disturbances in recent history as evidence by an existing underground telephone cable (see Image 16) and road grading. The proposed underground distribution line would run between the existing road and the existing underground telephone cable. The potential for additional impacts in the area is considered limited as construction techniques used for the installation of the existing telephone cable would be similar for the distribution line. Additional discussion regarding construction effects, mitigation and monitoring are provided in the Construction Plan Report.

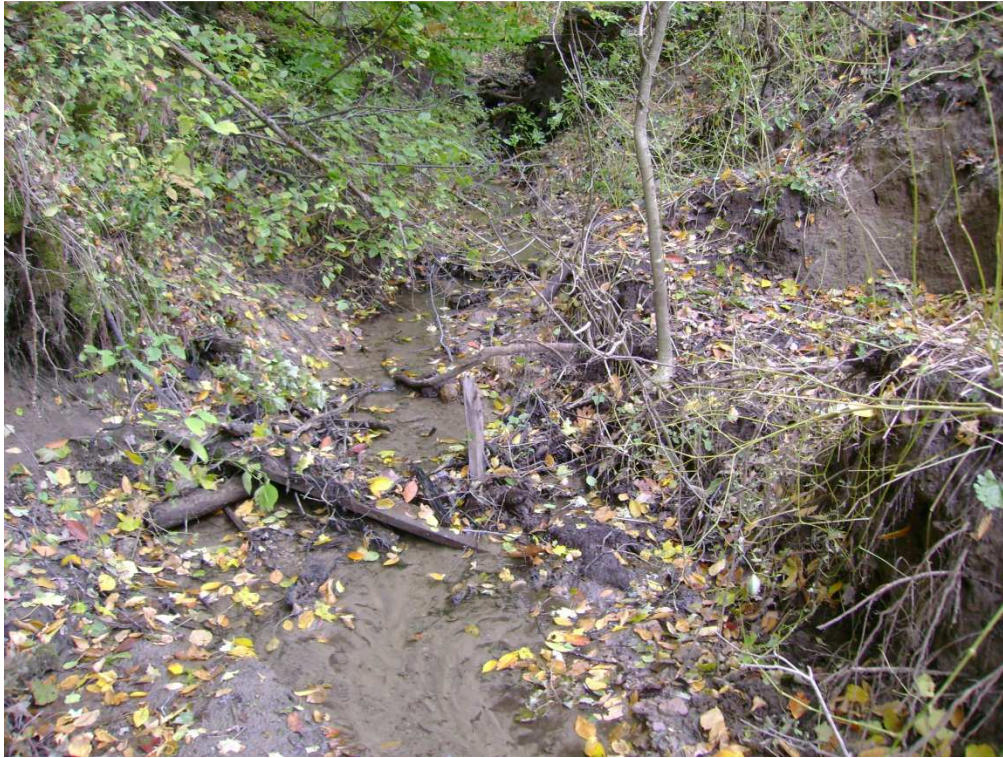
Photograph 1 – Upstream view of Tributary A (Silver Creek subwatershed) at assessment location WB-02 (October 15, 2009)

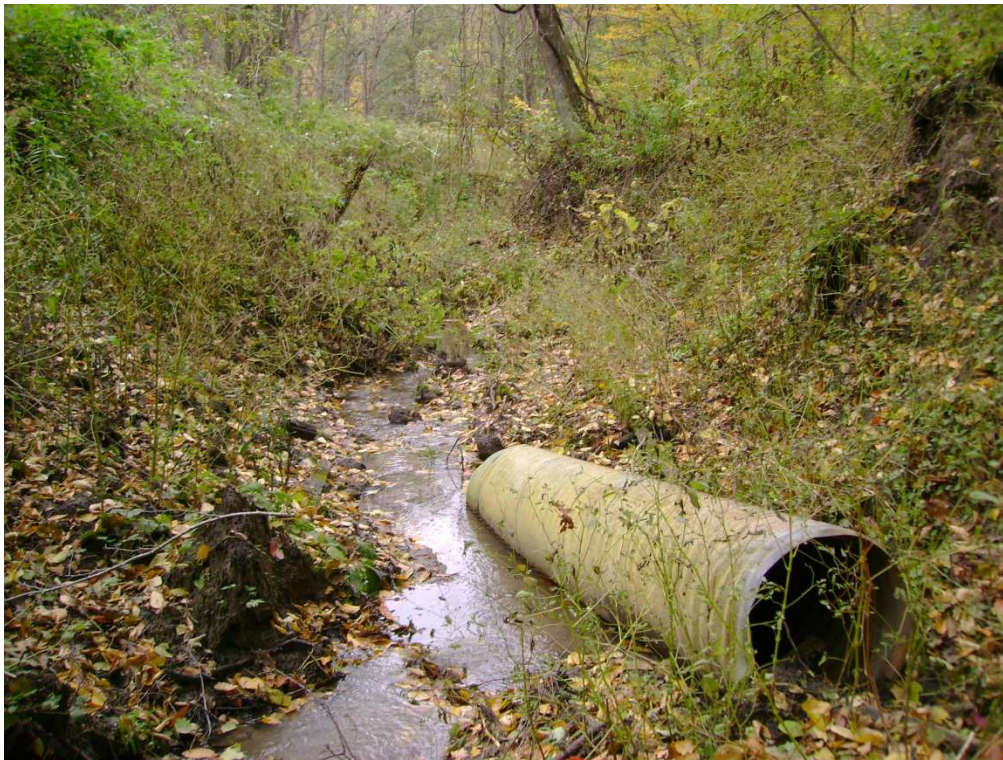
Photograph 2 – Downstream view of Tributary A (Silver Creek subwatershed) at assessment location WB-02 (October 15, 2009)

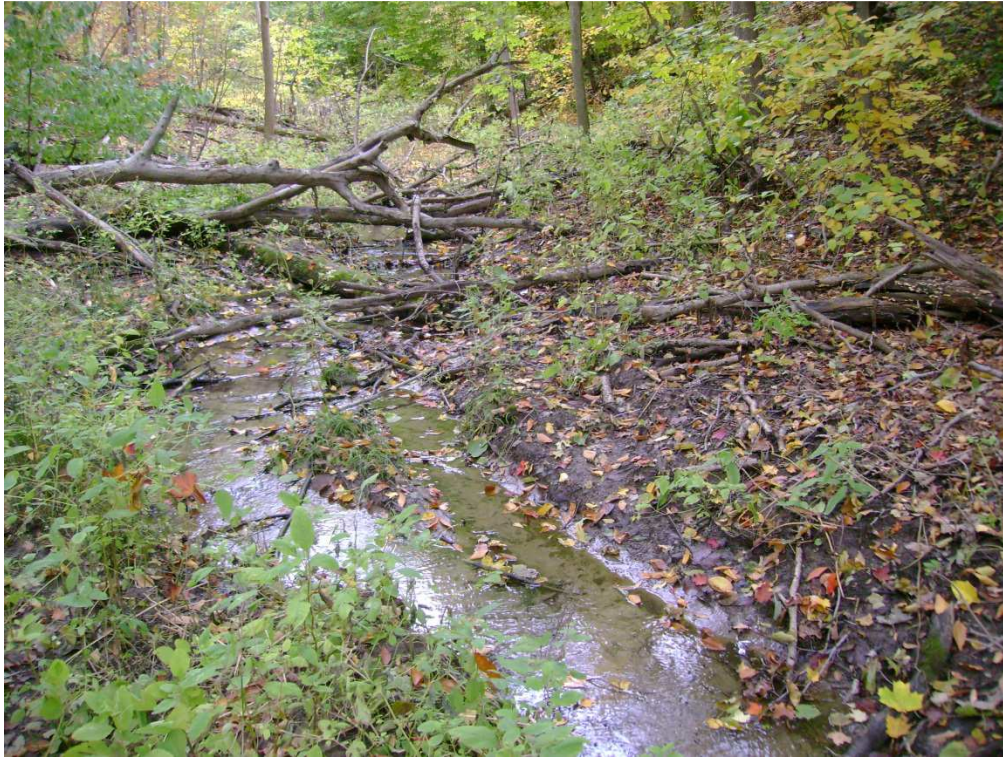
Photograph 3 – Upstream view of Tributary A (Silver Creek subwatershed) at assessment location WB-08 (October 15, 2009)

The identified locations of groundwater seepage were observed at the headwaters and within the banks of Tributary A, and at the headwaters of Tributary C within the Silver Creek subwatershed. These areas were observed at assessment locations WB-08 and WB-04, respectively (Figures 3 and 4).

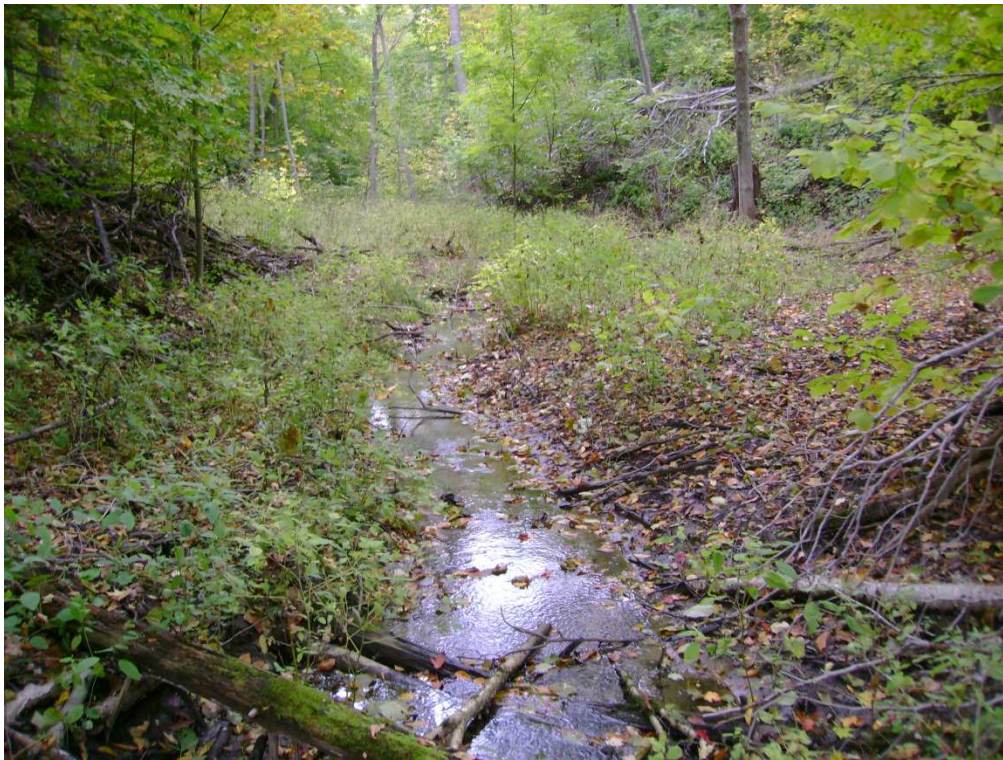
Photograph 4 – Downstream view of Tributary A (Silver Creek subwatershed) at assessment location WB-08 (October 15, 2009)

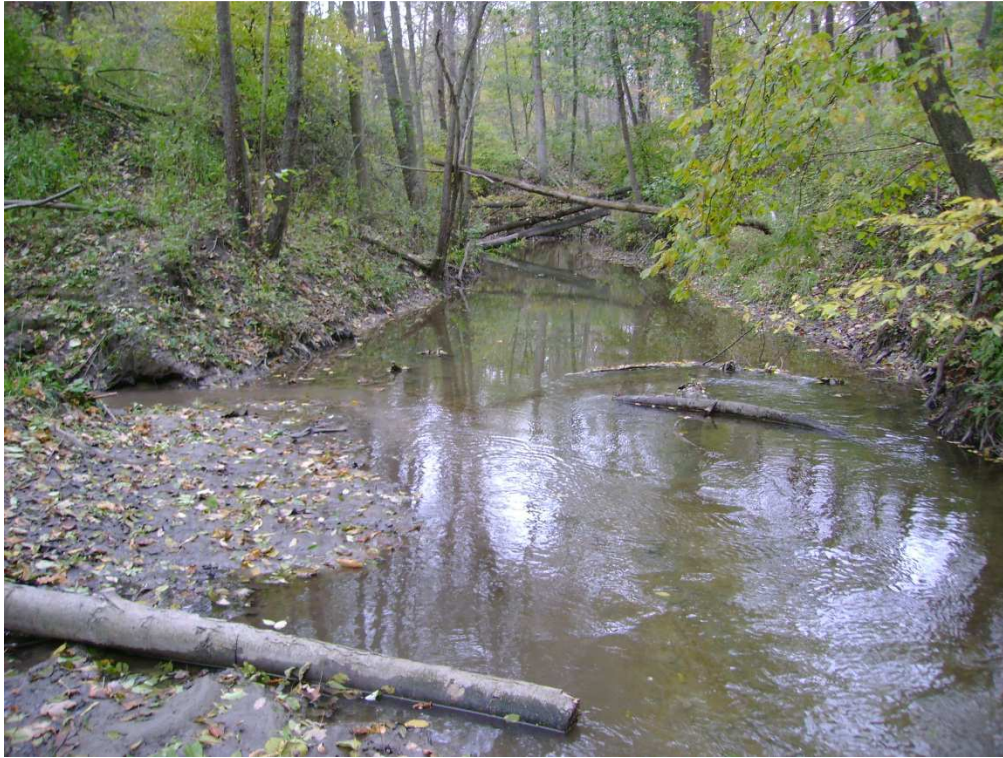
Photograph 5 – Upstream view of Silver Creek at assessment location WB-01 (October 15, 2009)

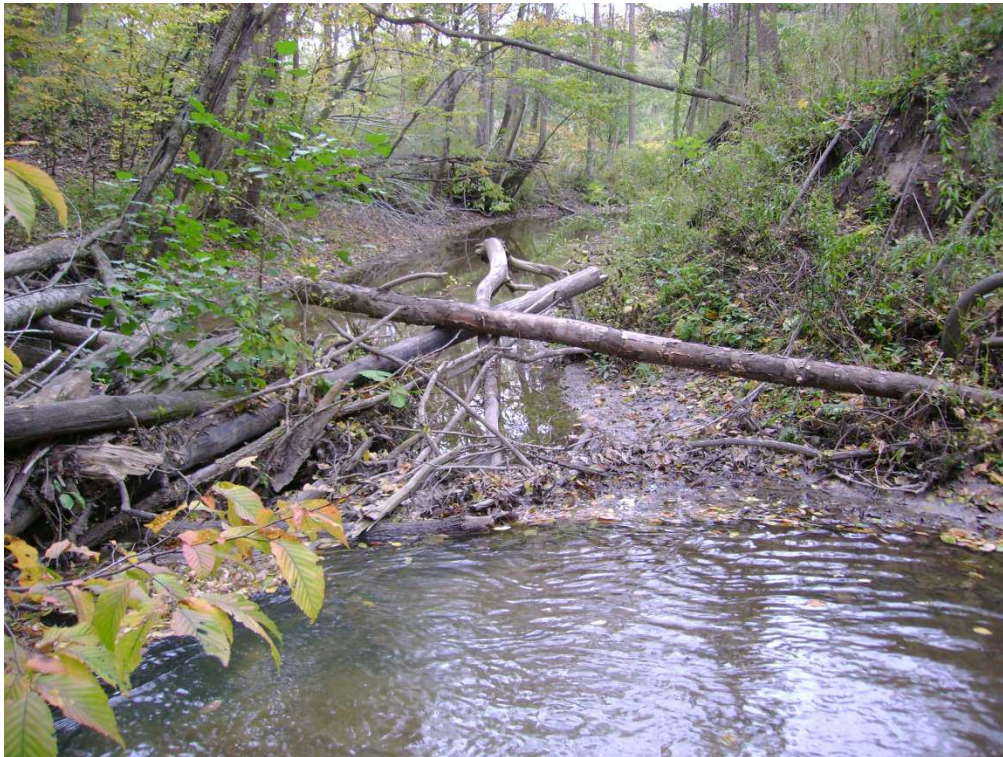
Photograph 6 – Downstream view of Silver Creek downstream of assessment location WB-01 (October 15, 2009)

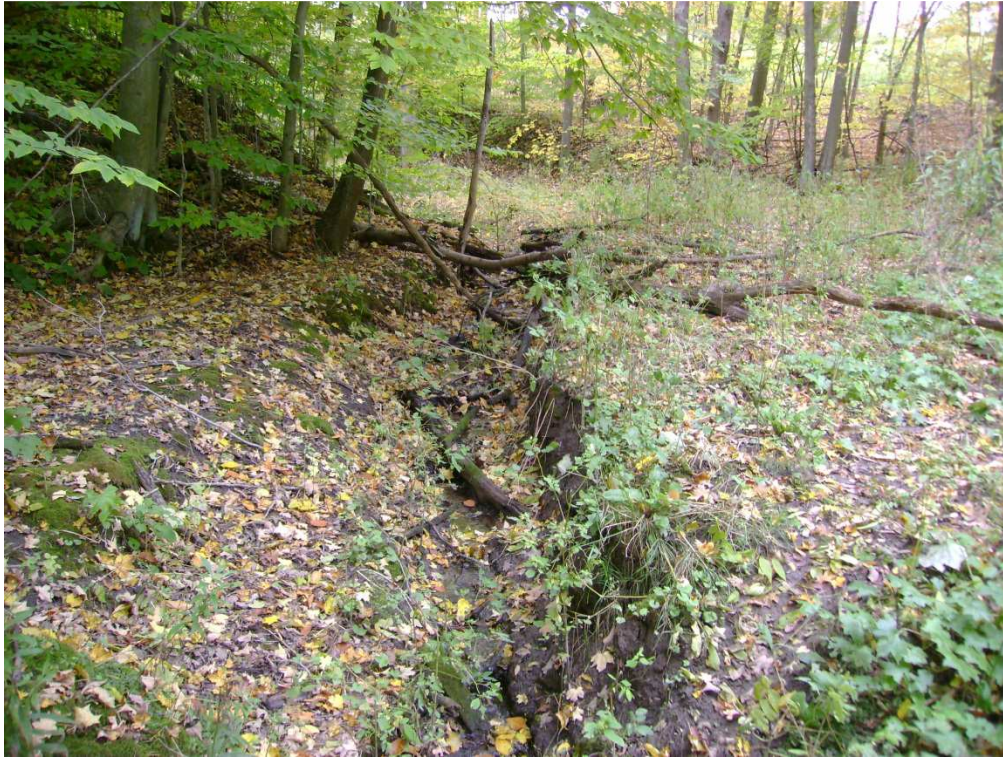
Photograph 7 – Upstream view of Tributary B (Silver Creek subwatershed) at assessment location WB-03 (October 15, 2009)

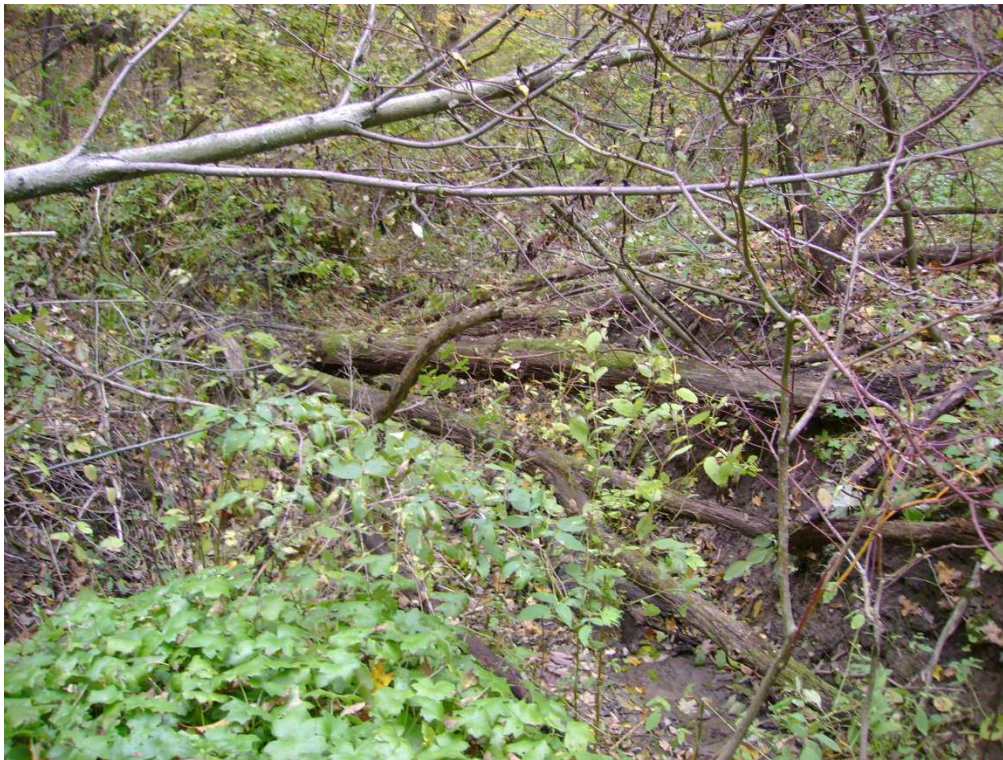
Photograph 8 – Downstream view of Tributary B (Silver Creek subwatershed) at assessment location WB-03 (October 15, 2009)

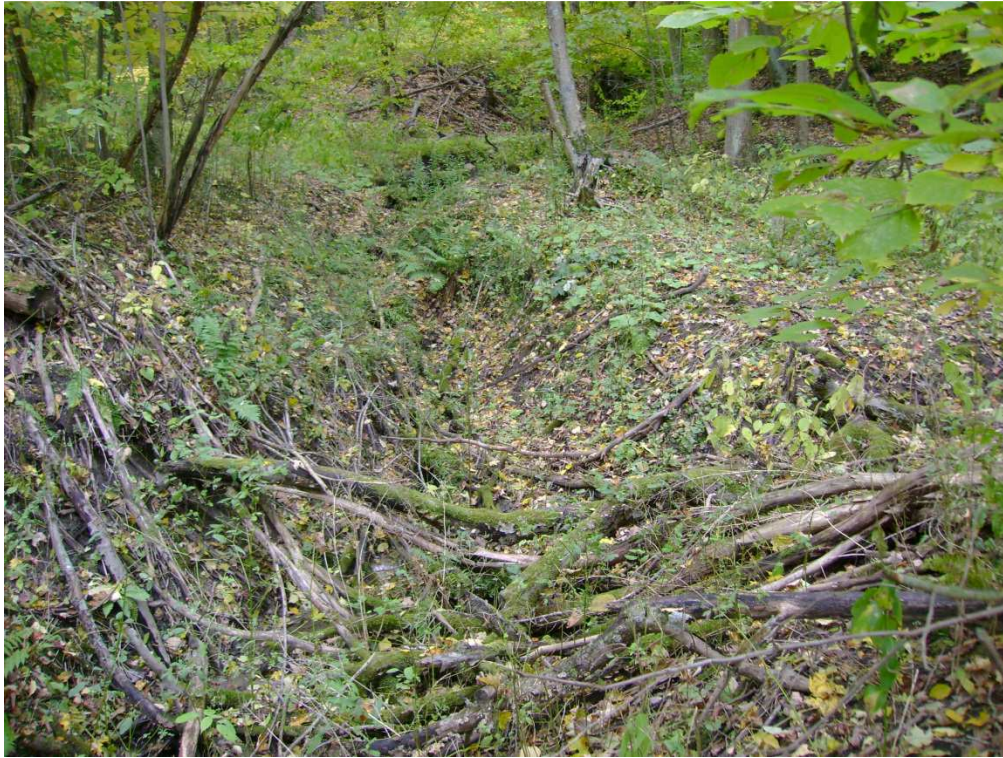
Photograph 9 – Upstream view of Tributary C (Silver Creek subwatershed) at assessment location WB-04 (October 15, 2009)

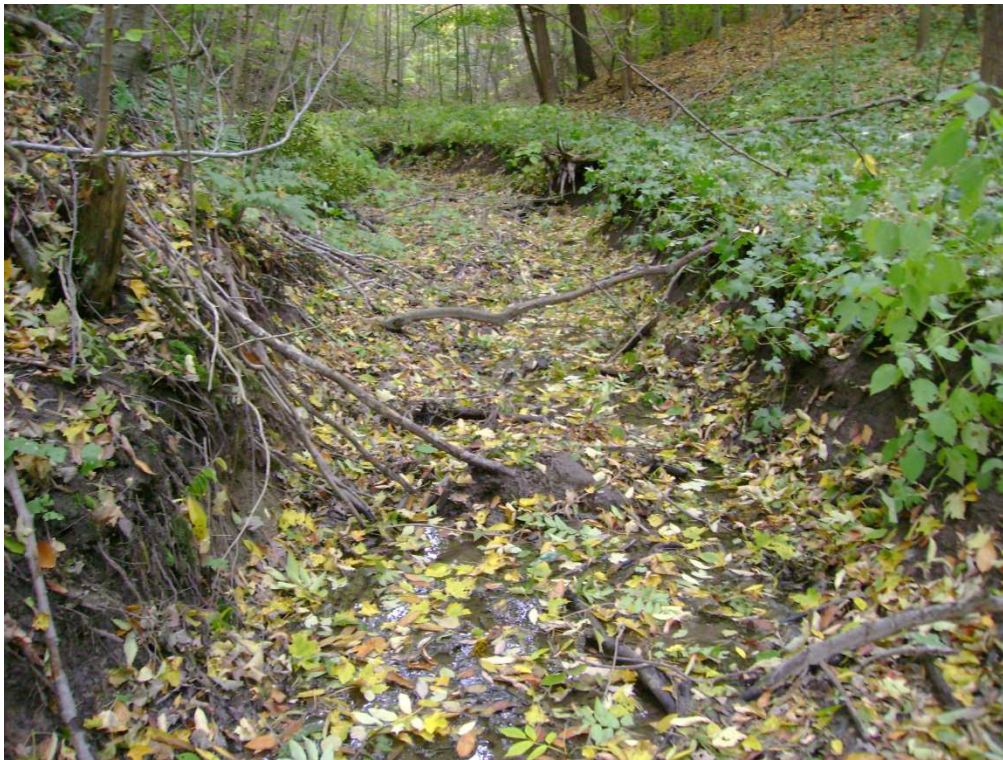
Photograph 10 – Upstream view of Tributary D (Silver Creek subwatershed) at assessment location WB-05 (October 15, 2009)

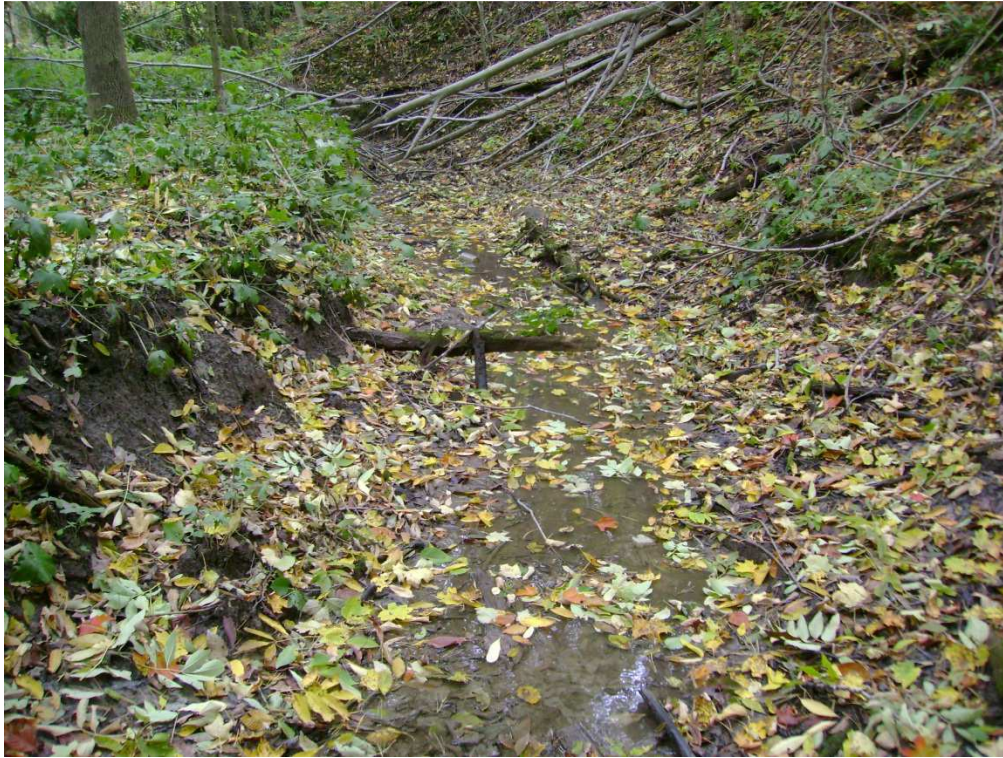
Photograph 11 – Downstream view of Tributary D (Silver Creek subwatershed) at assessment location WB-05 (October 15, 2009)

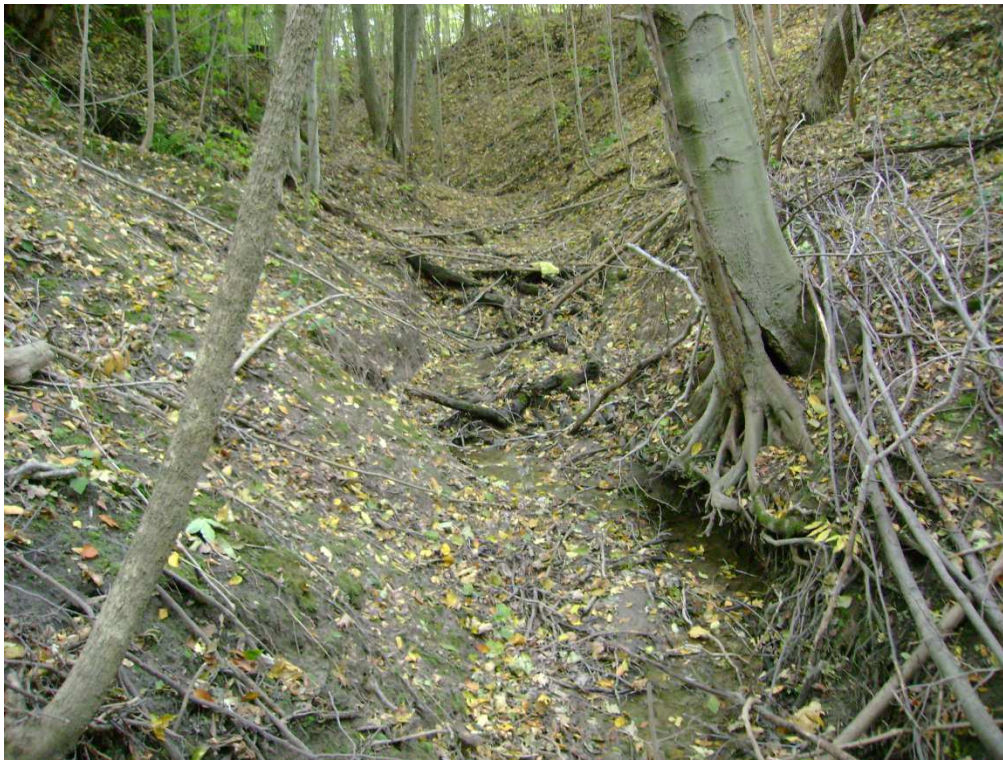
Photograph 12 – Upstream view of Tributary D (Silver Creek subwatershed) at assessment location WB-06 (October 15, 2009)

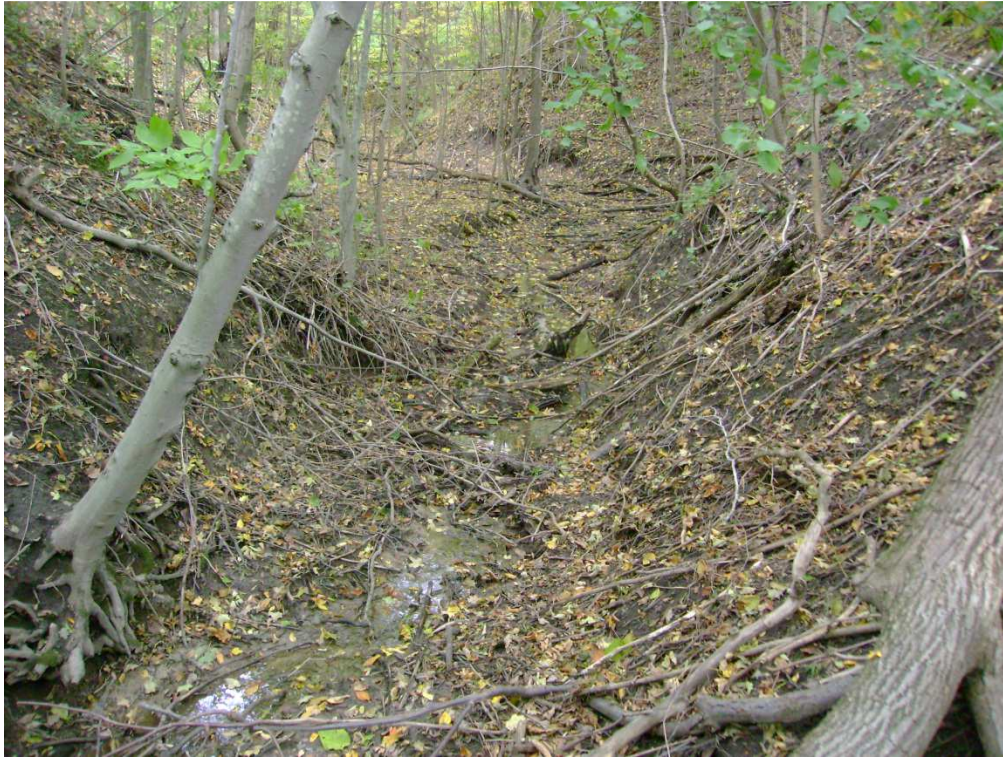
Photograph 13 – Upstream view of Tributary D (Silver Creek subwatershed) at assessment location WB-06 (October 15, 2009)

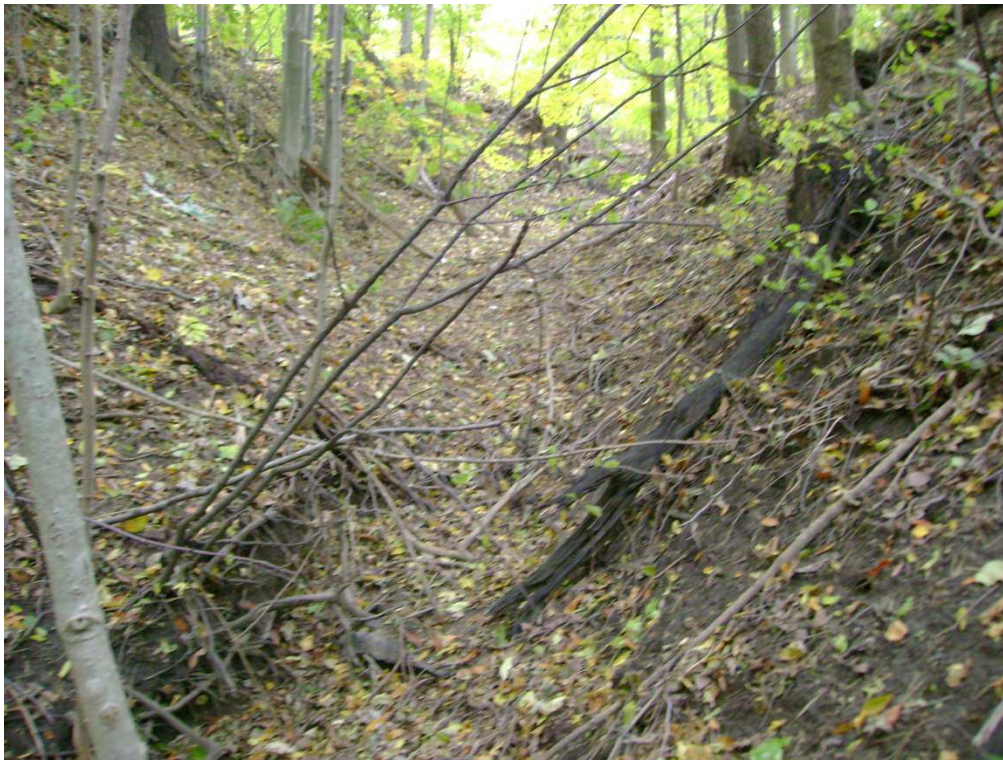
Photograph 14 – Upstream view of Tributary E (Silver Creek subwatershed) at assessment location WB-07 (October 15, 2009)

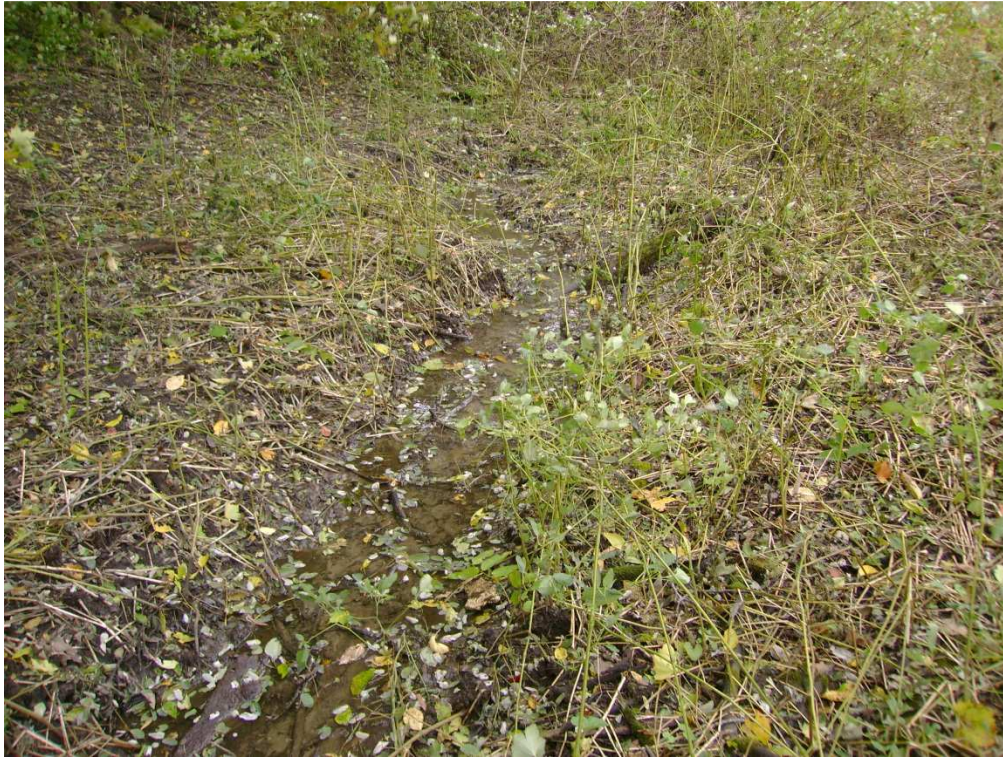
Photograph 15 – Upstream view of Tributary D (Silver Creek subwatershed) at assessment location WB-08 (October 15, 2009)

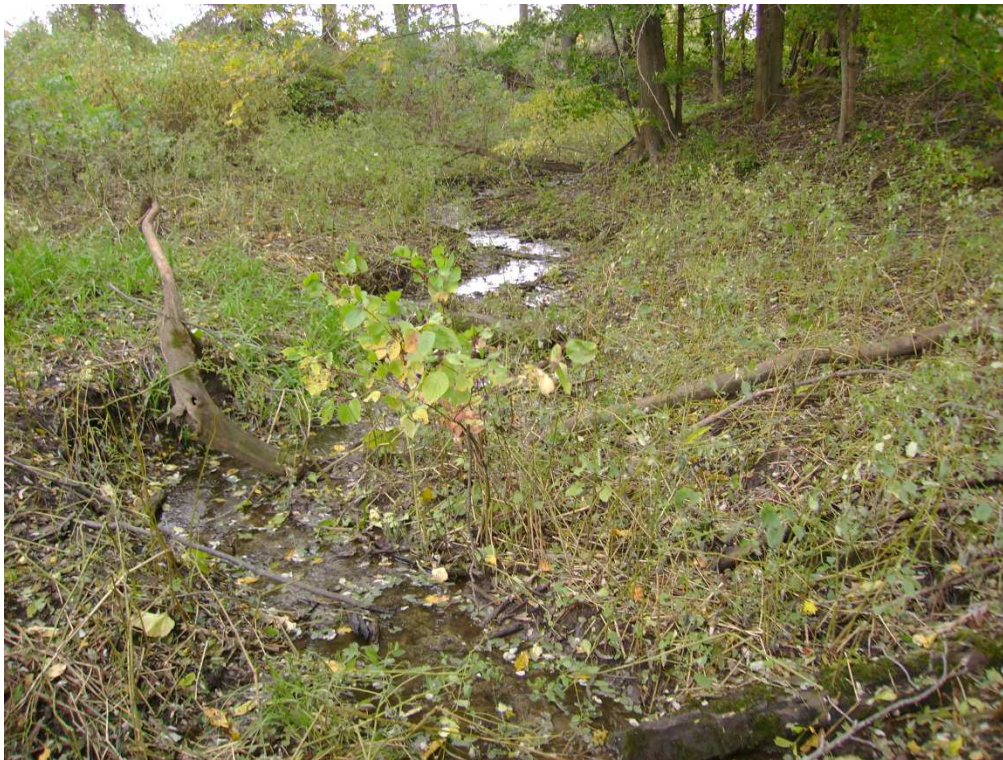
Photograph 16 – Downstream view of Tributary D (Silver Creek subwatershed) at assessment location WB-08 (October 15, 2009)

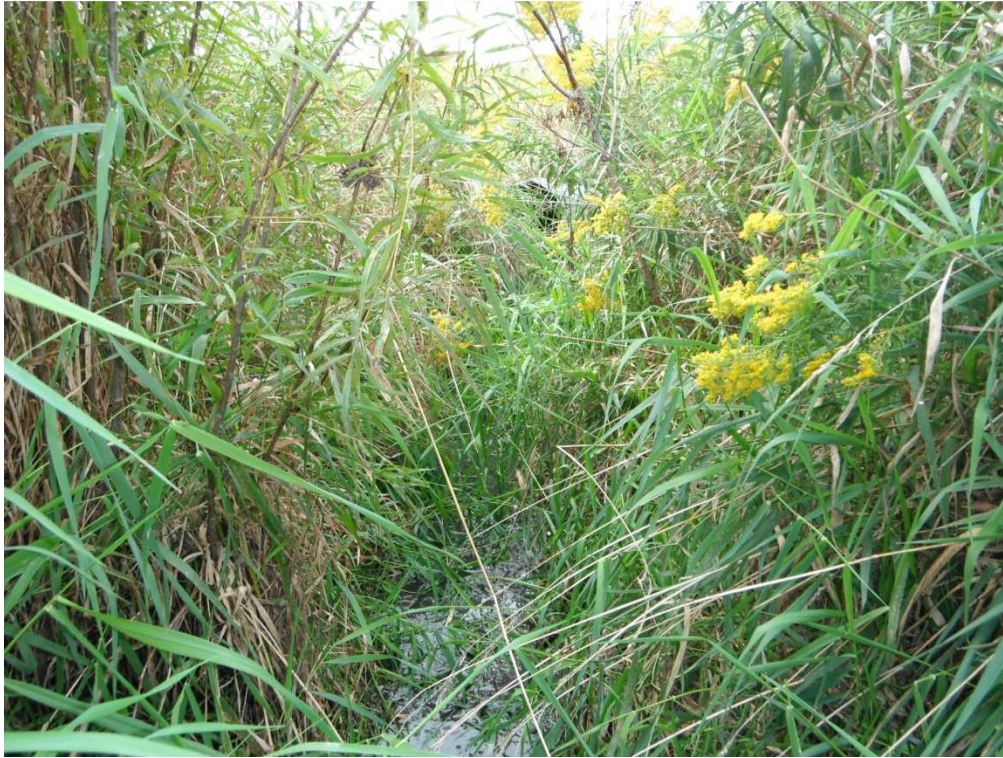
Photograph 17 – Upstream view of Gracey Drain (Catfish Creek subwatershed) at assessment location WB-09 (September 16, 2011)

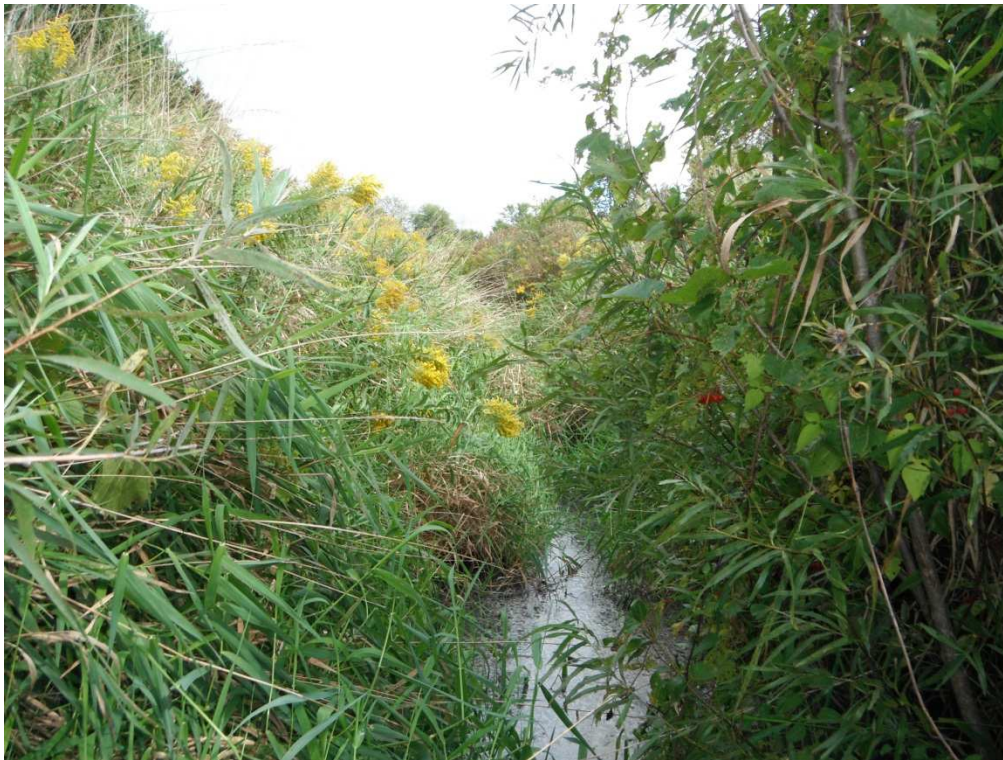
Photograph 18 – Downstream view of Gracey Drain (Catfish Creek subwatershed) at assessment location WB-09 (September 16, 2011)

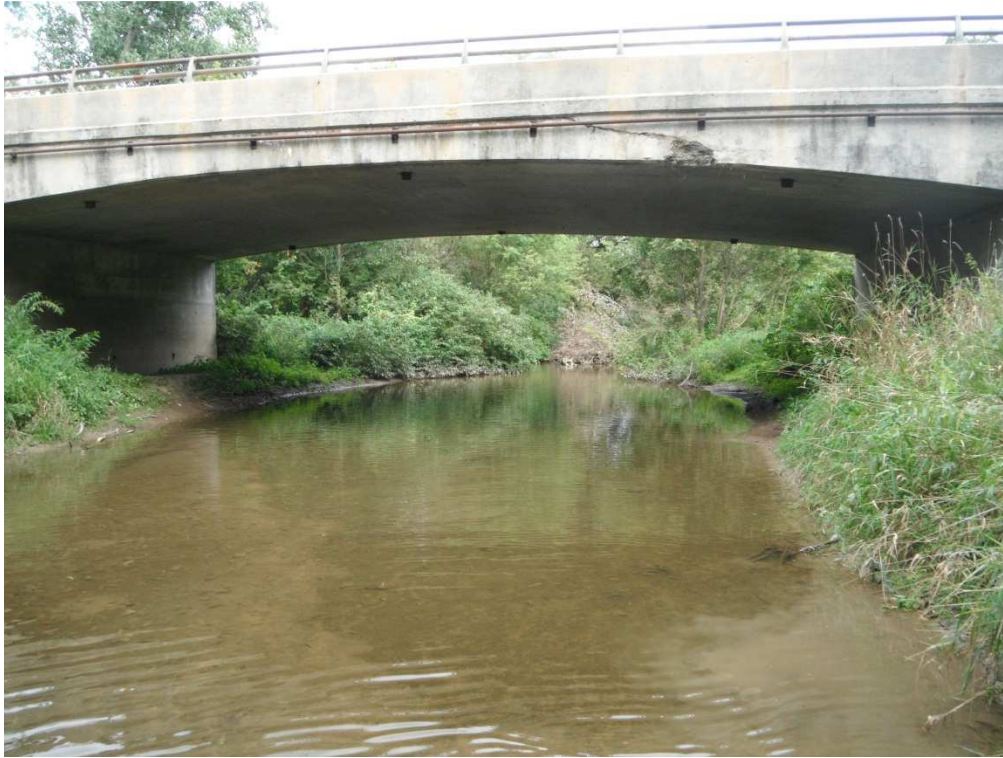
Photograph 19 – Upstream view of Catfish Creek at assessment location WB-10 (September 16, 2011)

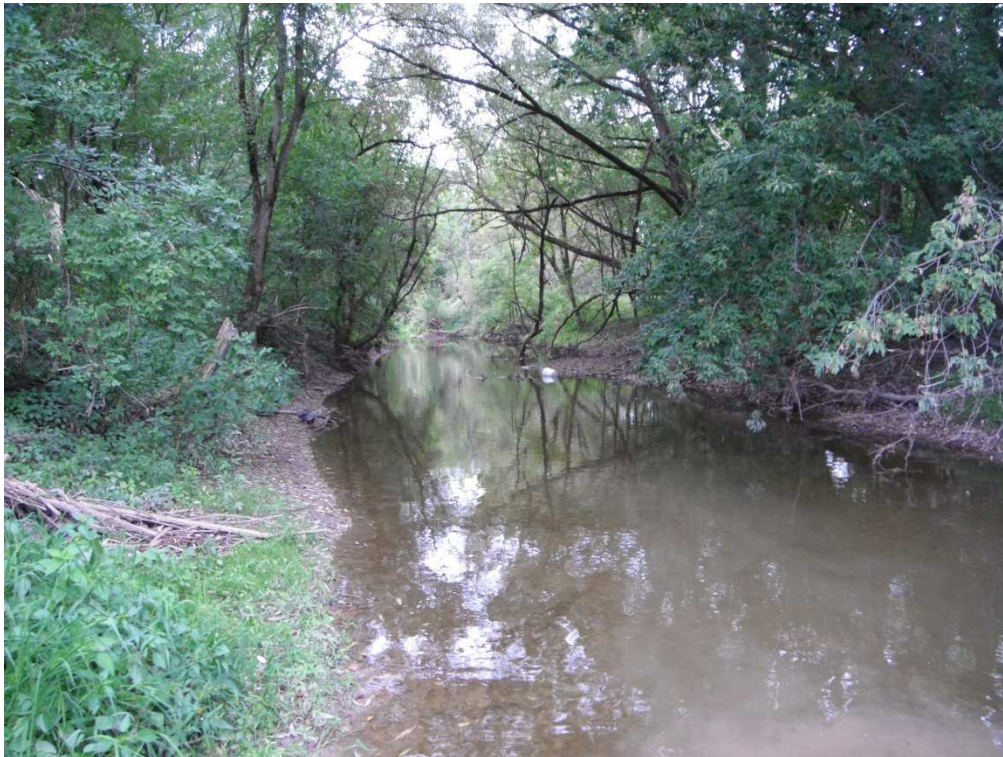
Photograph 20 – Downstream view of Catfish Creek at assessment location WB-10 (September 16, 2011)

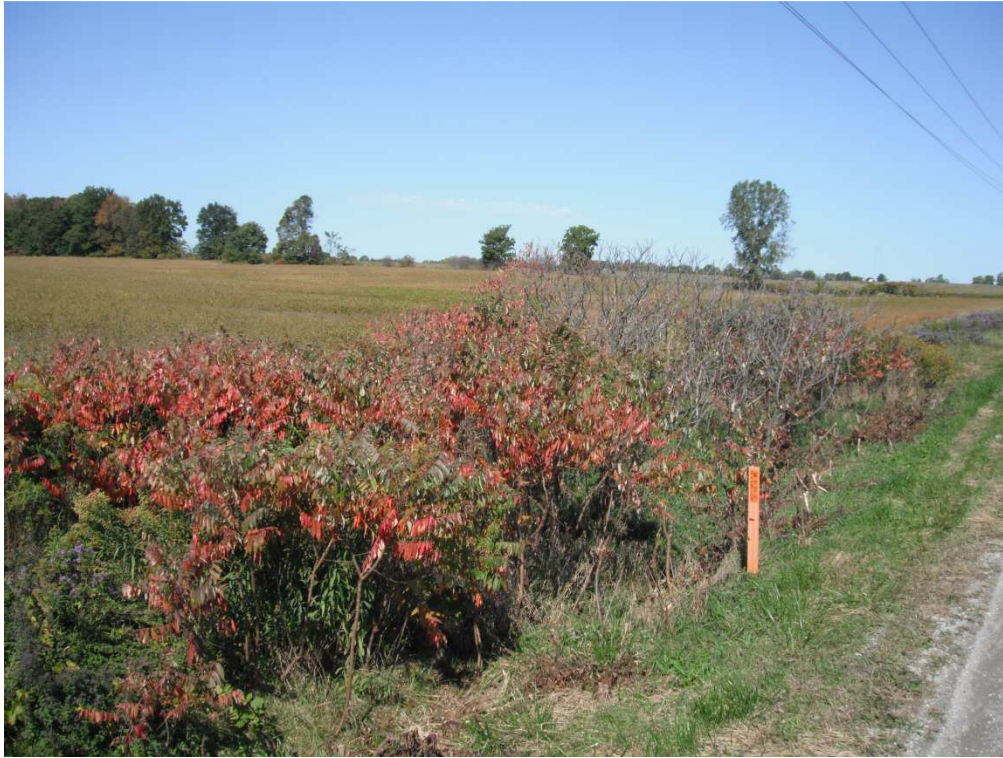
Photograph 21 – Upstream view of Tributary F (Silver Creek subwatershed) at assessment location WB-15 (October 4, 2011)

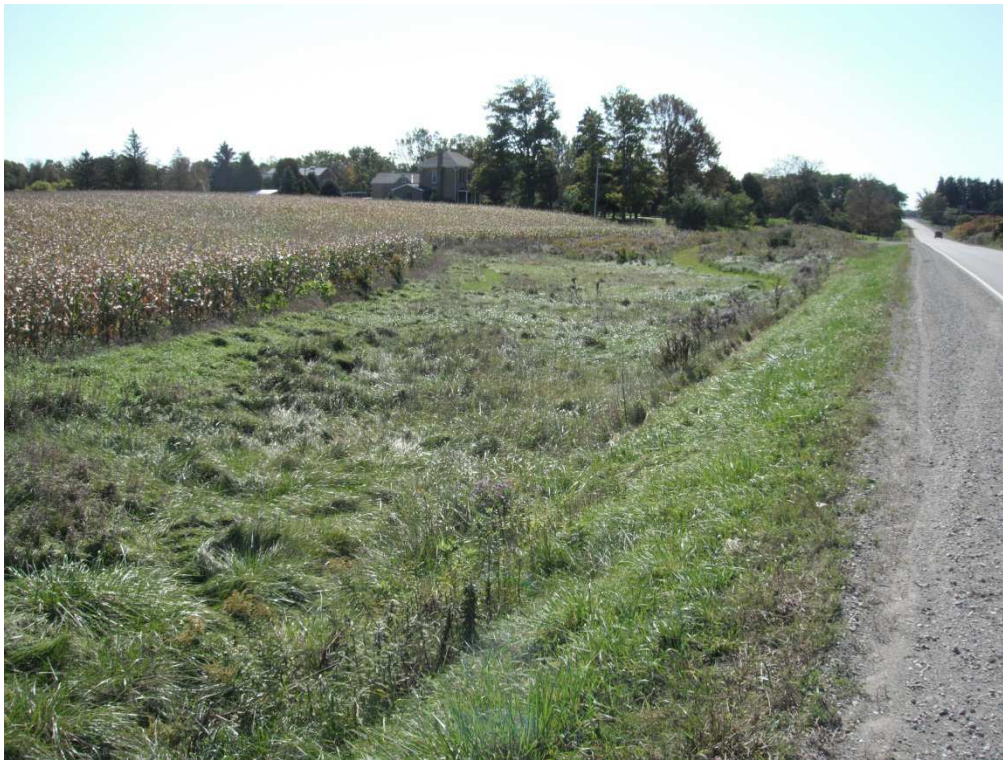
Photograph 22 – Downstream view of Tributary F (Silver Creek subwatershed) at assessment location WB-15 (October 4, 2011)

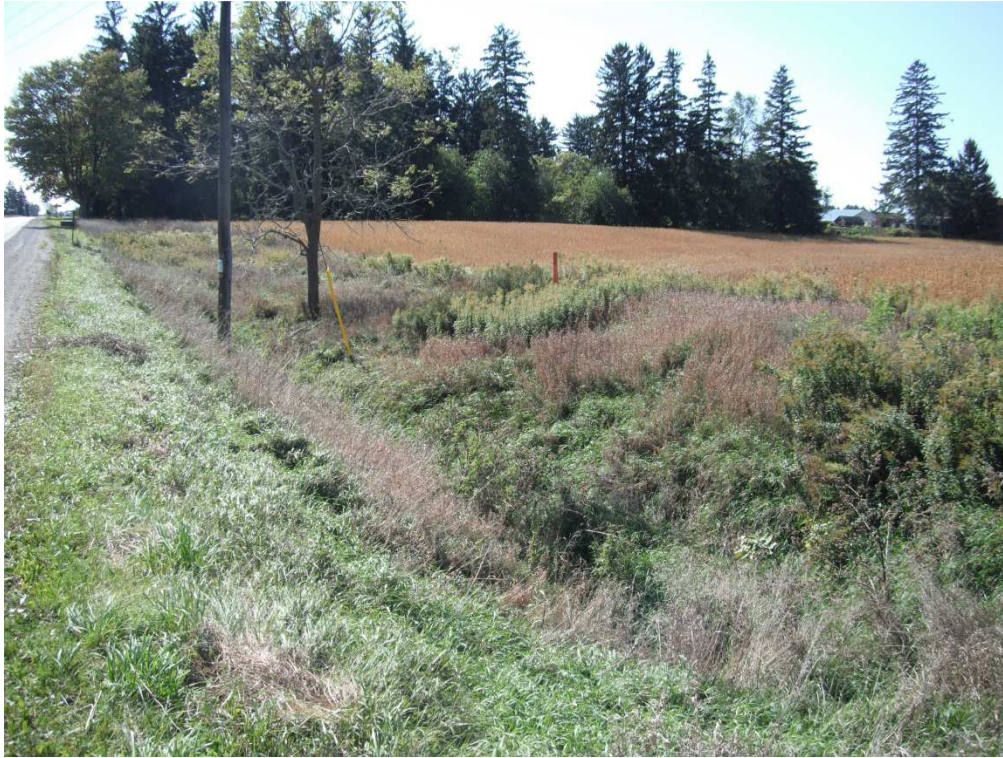
Photograph 23 – Upstream view of Tributary F (Silver Creek subwatershed) at assessment location WB-16 (October 4, 2011)

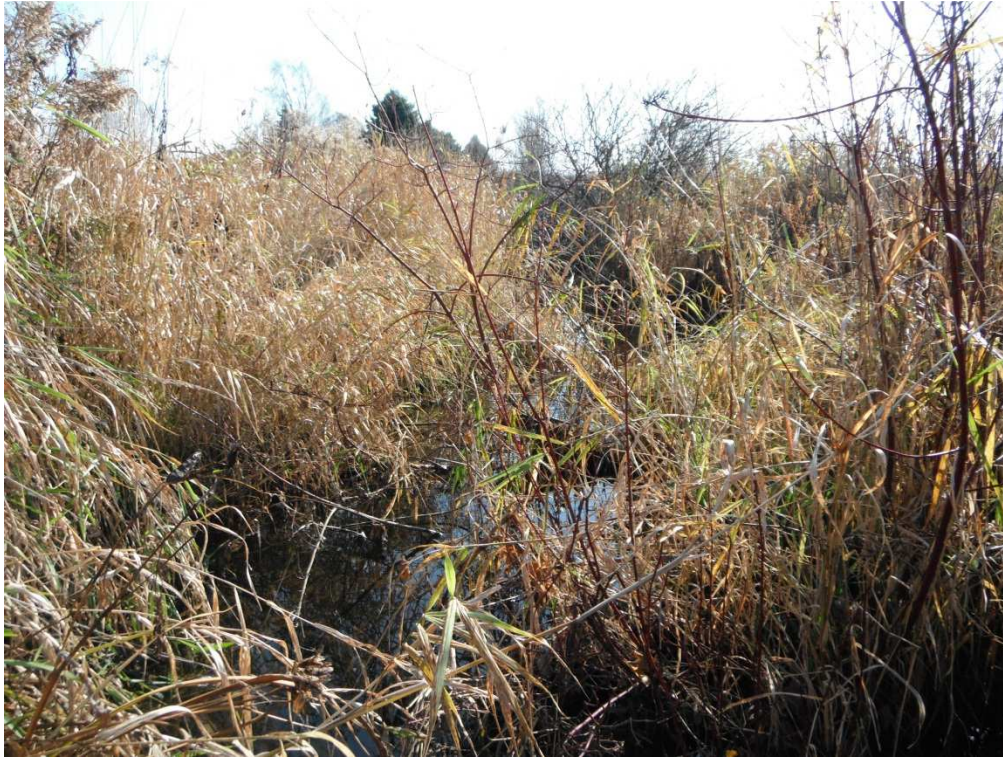
Photograph 27 – Upstream view of Tributary C (Bradley Creek subwatershed) at assessment location WB-19 (November 8, 2011)

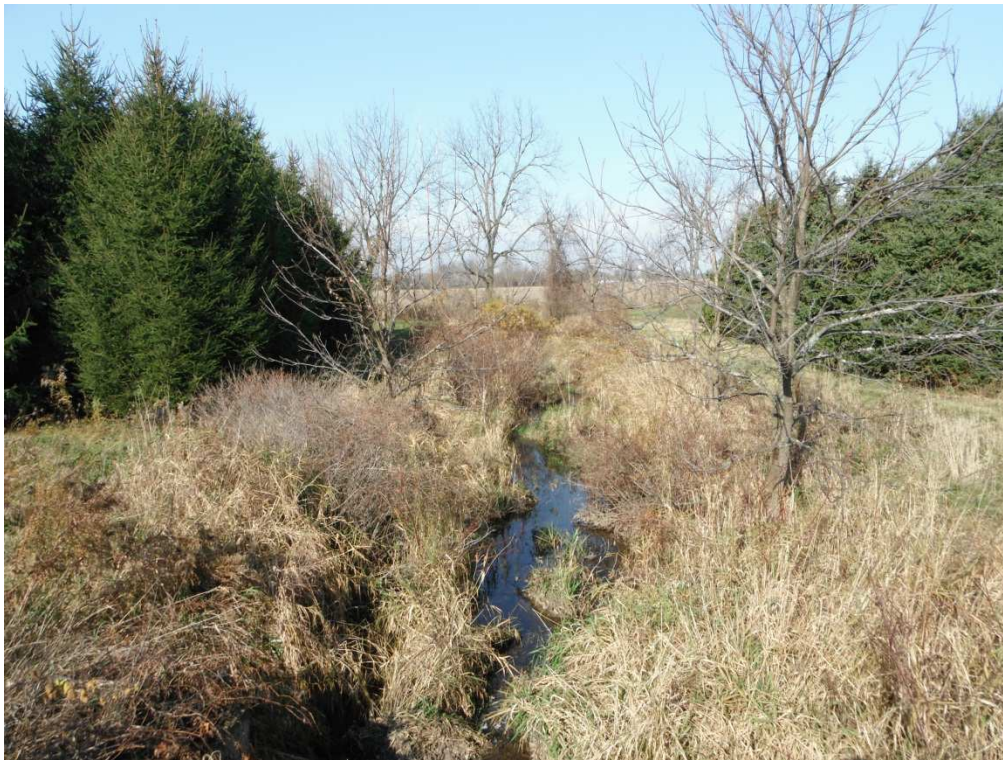
Photograph 28 – Downstream view of Tributary C (Bradley Creek subwatershed) at assessment location WB-19 (November 8, 2011)

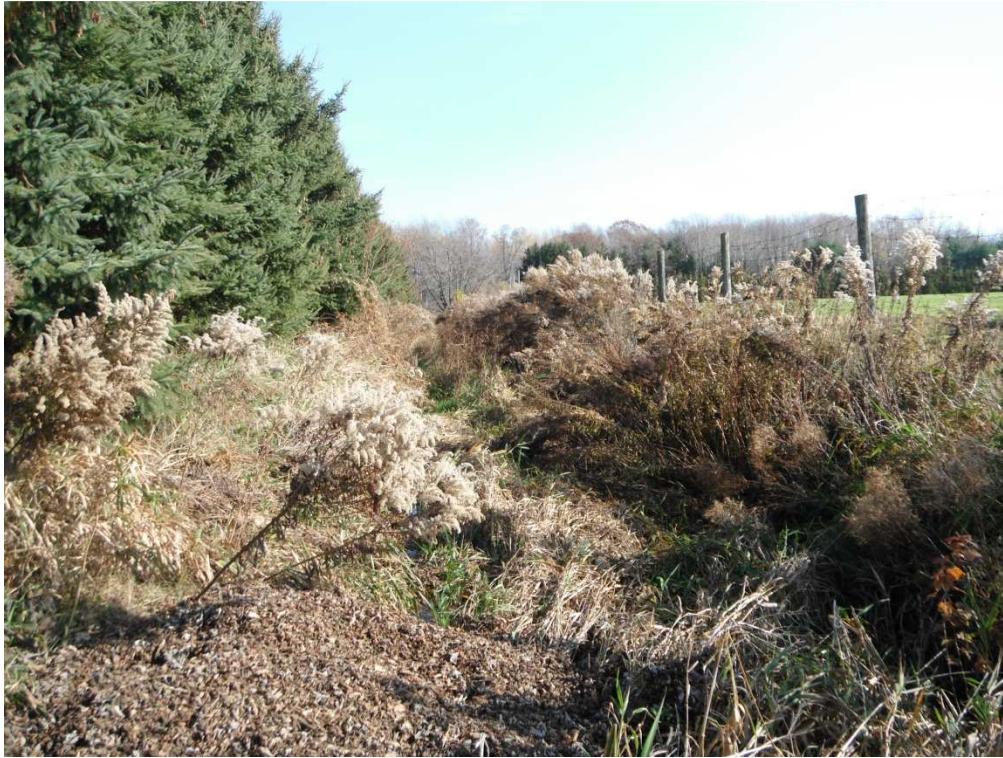
Photograph 29 – Upstream view of Tributary A (Bradley Creek subwatershed) at assessment location WB-20 (November 8, 2011)

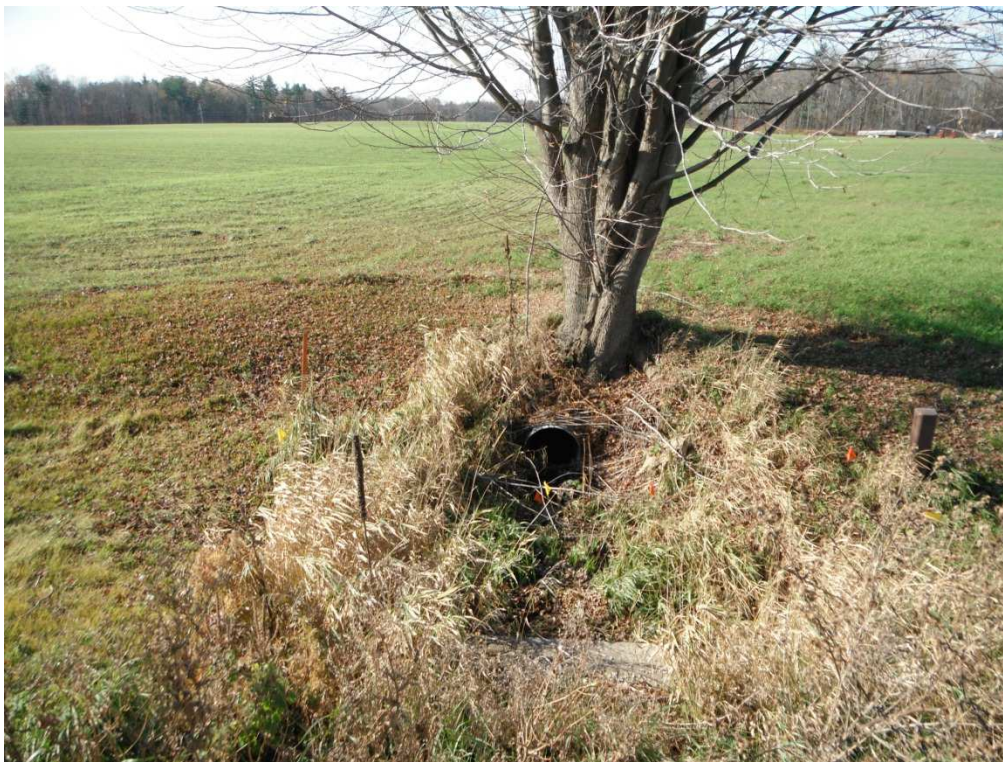
Photograph 30 – Downstream view of Tributary A (Bradley Creek subwatershed) at assessment location WB-20 (November 8, 2011)

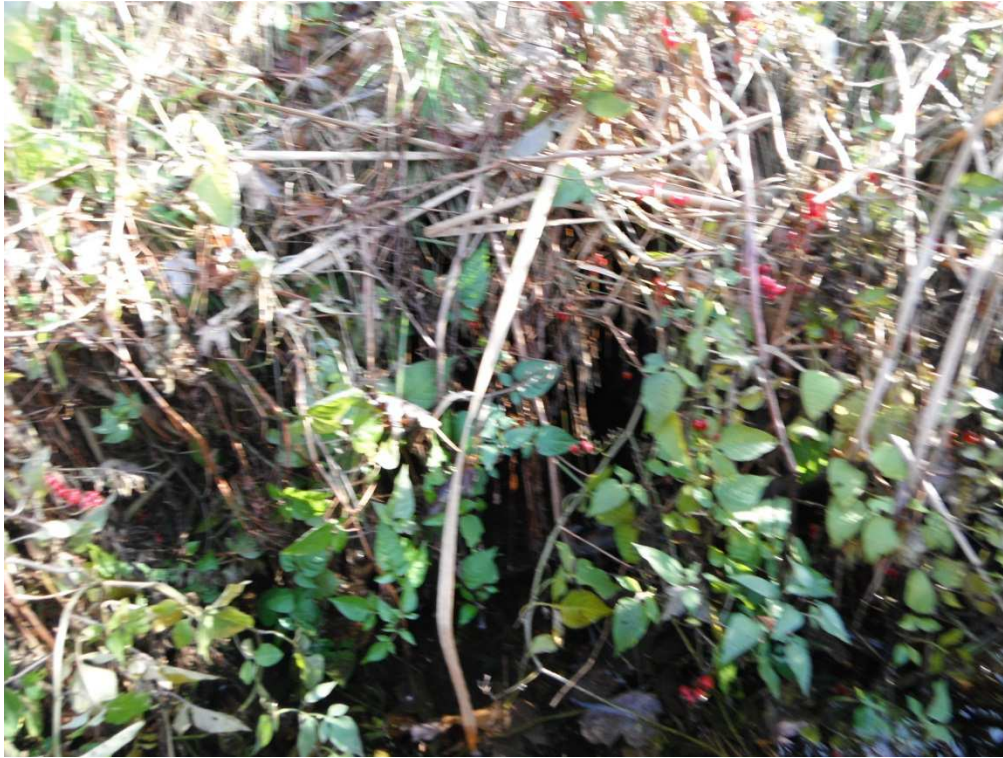
Photograph 31 – Upstream view of Tributary B (Silver Creek subwatershed) at assessment location WB-21 (November 8, 2011)
