Design and Operations Report Silvercreek Solar Park

Report No.: 70287
28 pages, 5 Appendices

Date: November 30, 2012

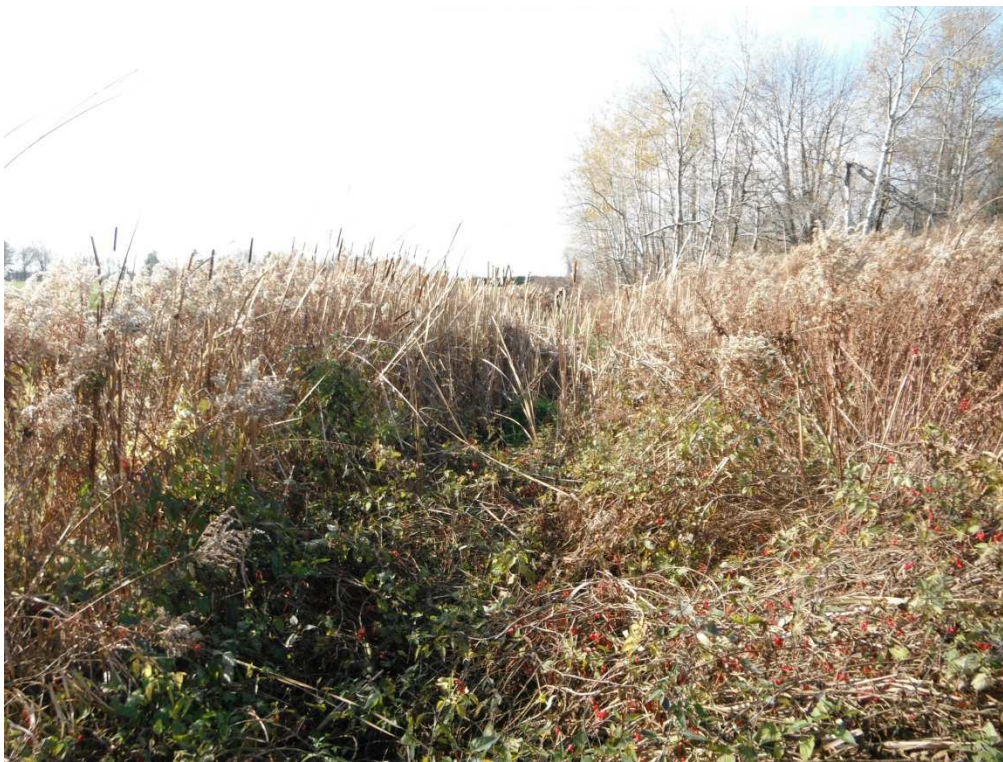
Photograph 32 – Downstream view of Tributary B (Silver Creek subwatershed) at assessment location WB-21 (November 8, 2011)

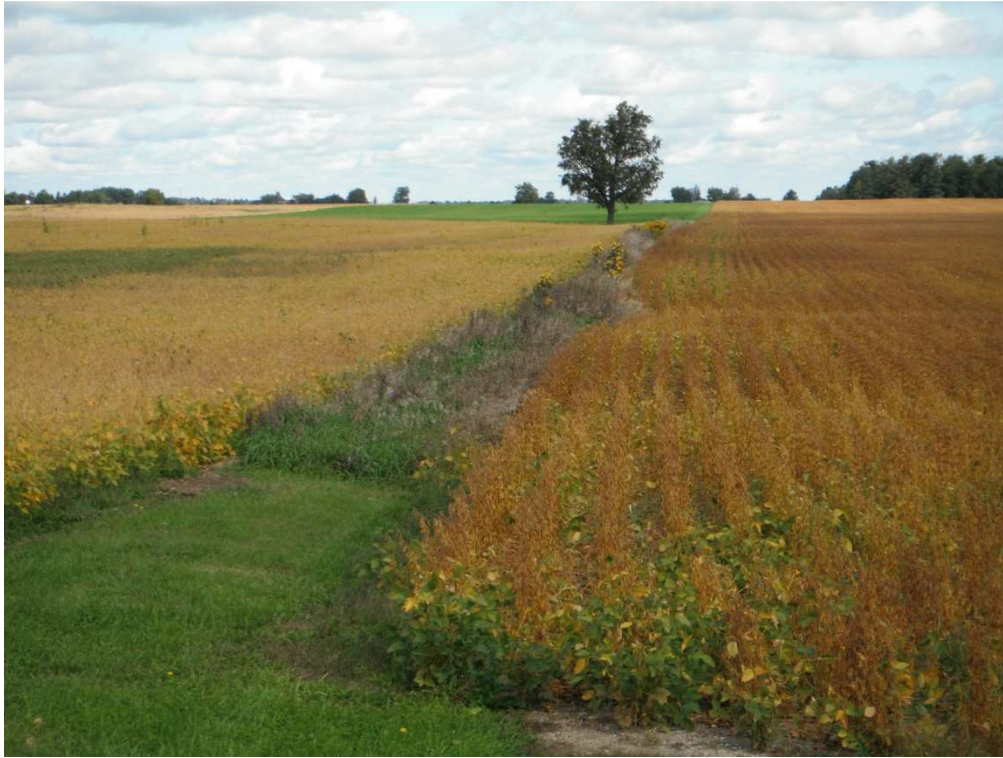
Photograph 33 – Upstream view of Argyle Drain facing north from Glencolin Line (Catfish Creek subwatershed) at assessment location WB-25 (November 8, 2011)

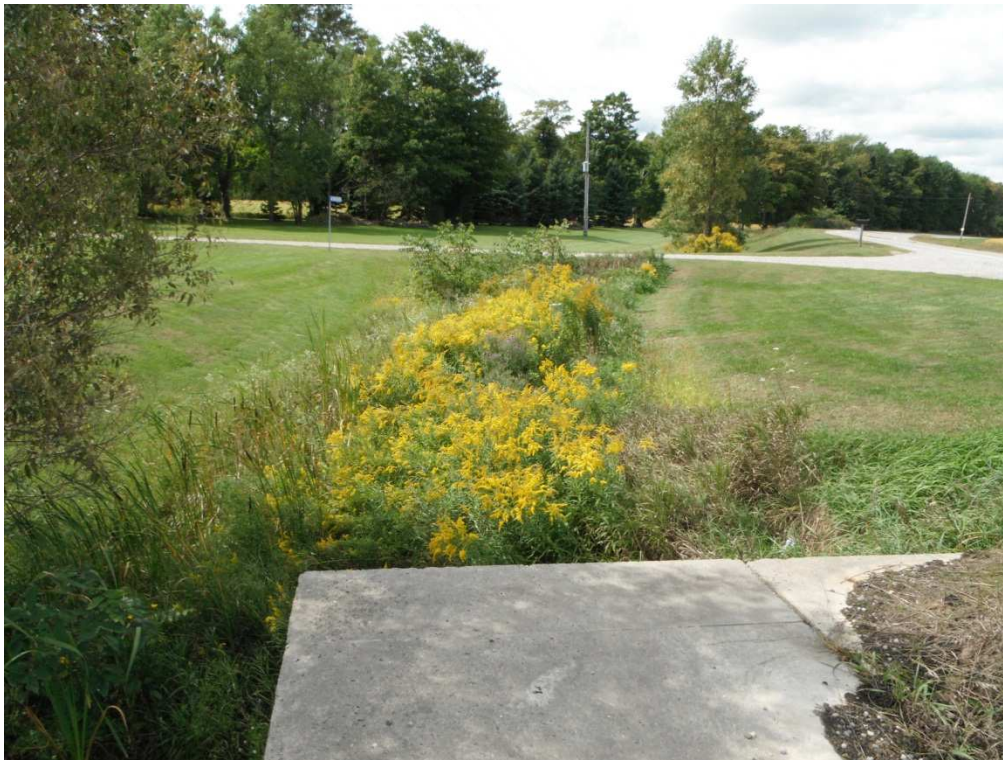
Photograph 34 – Southwest view of Argyle Drain along south side of Glencolin Line (Catfish Creek subwatershed) at assessment location WB-25 (September 16, 2011)

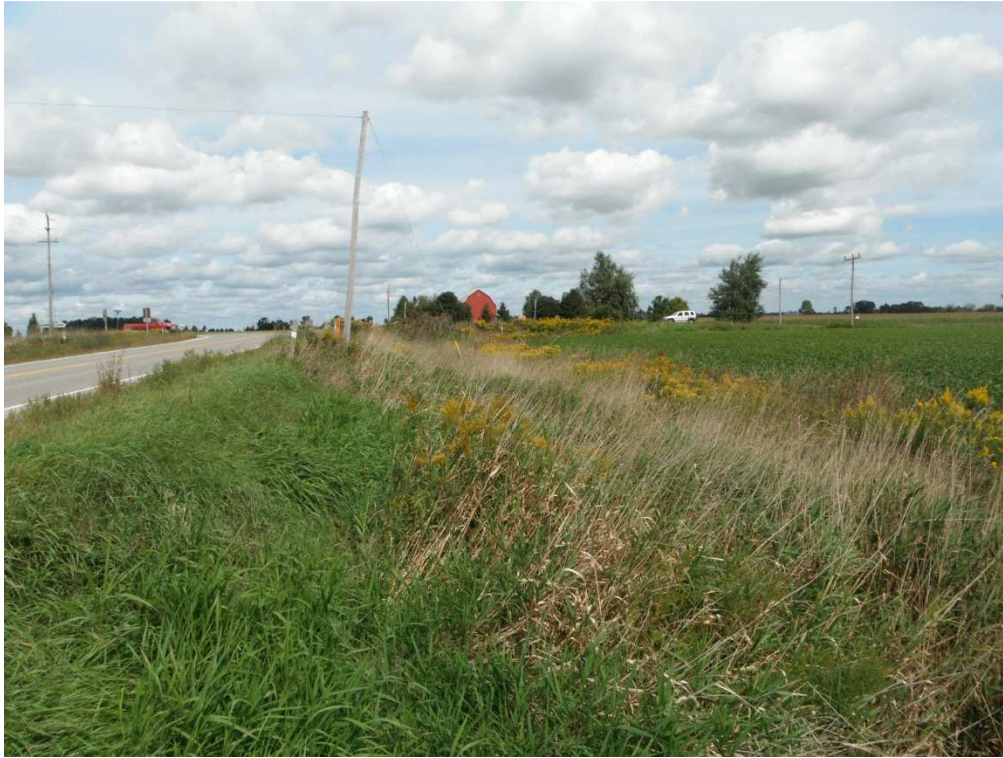
Photograph 35 – Upstream view of Gracey Drain facing north along the east side of Hacienda Road (Catfish Creek subwatershed) at assessment location WB-26 (November 8, 2011)

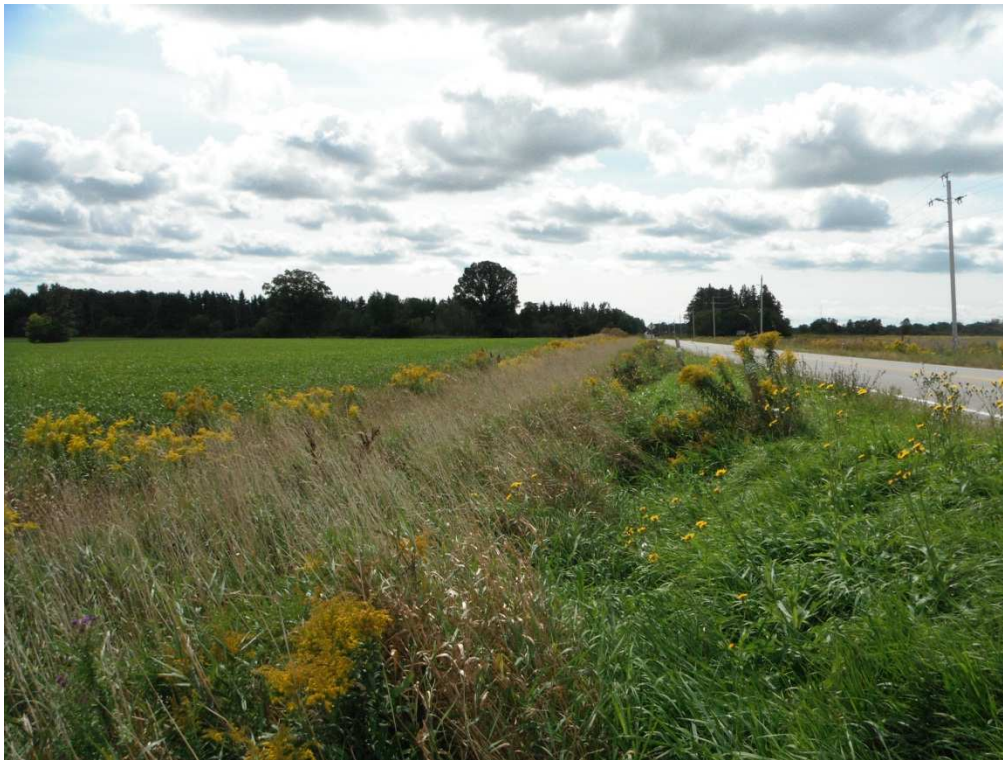
Photograph 36 – Downstream view of Gracey Drain facing south along the east side of Hacienda Road (Catfish Creek subwatershed) at assessment location WB-26 (September 16, 2011)

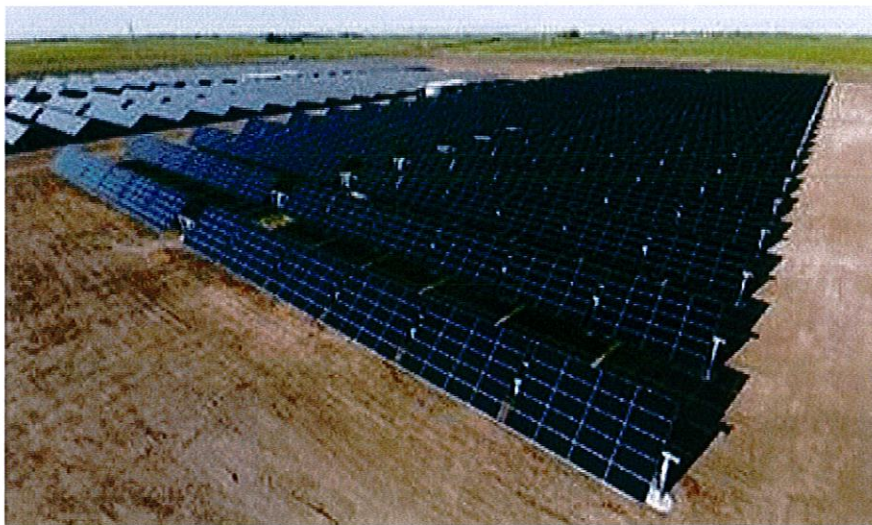
Figure 8: Solar Panels (Arrays)

Peter – below is a representative image of what the solar panels will look like when mounted on the tracking system. I have also attached the proposed solar panels for use (note they state 270W in the information, whereas in our reports we have used 275 W). 44,520 panels in total. I have also attached a brochure for the proposed tracking system.

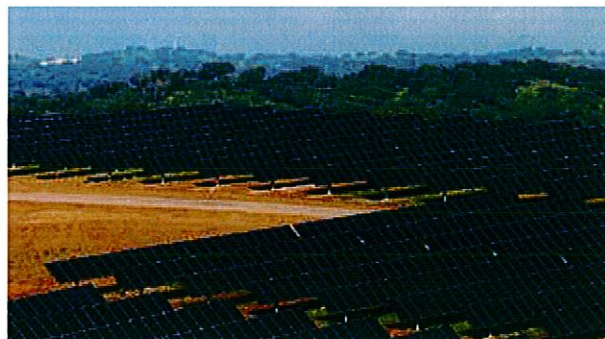
SunPower Tracker vs. Conventional Solar Tracking Systems: A 1MW System Comparison

Unlike conventional solar tracking systems that require wide array spacing, SunPower Tracker minimizes shading and thereby enables tighter spacing, requiring half the land area of conventional systems.
