**Stage 1 & 2 Archaeological Assessment
Silvercreek Solar Park
Substation and Transmission Line
Geographic Township of Malahide
Elgin County, Ontario
FIT REFERENCE #: FIT - FEA8Z1X**

Archaeological License: Arthur Figura, M.A., P083
Our File: 2011-103
PIF Number: P083-152-2011

December 2011

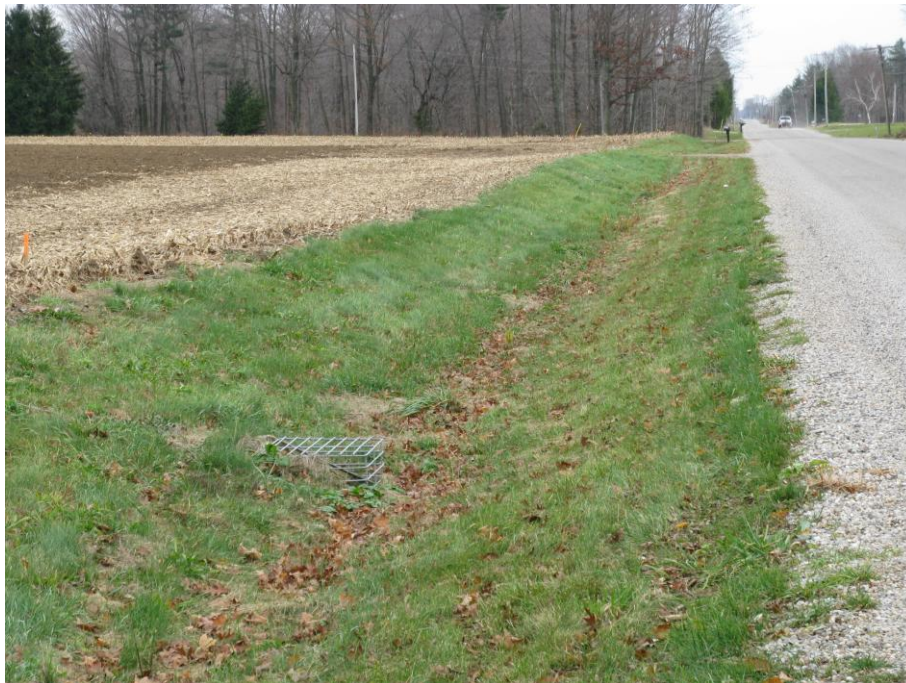
Image 10: Location of transmission line on the north side of Vienna Line, looking east (note ditching and sewer)

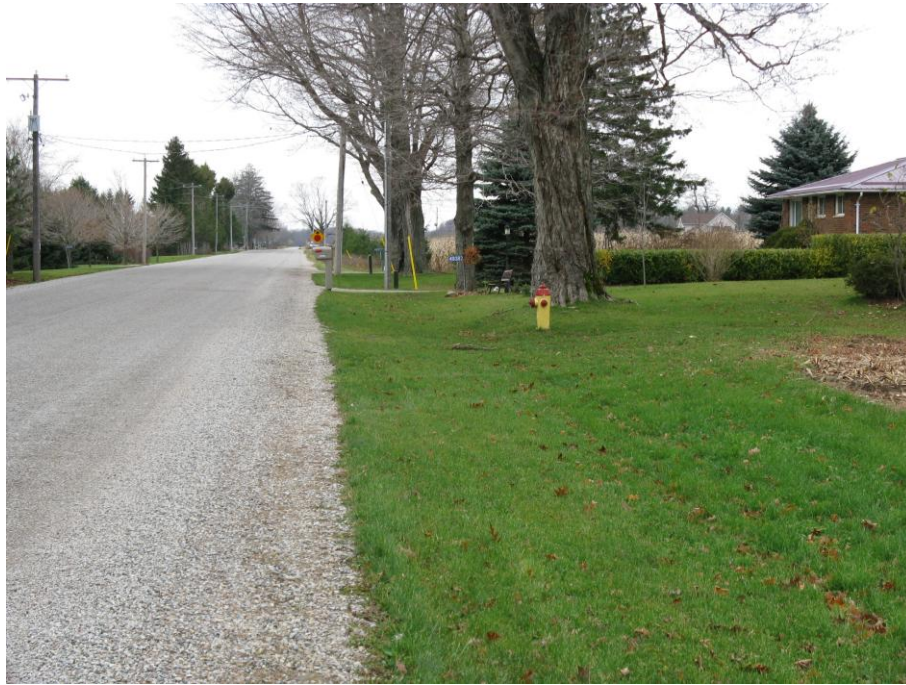
Image 11: Location of transmission line on the north side of Vienna Line, looking west (note ditching and fire hydrant)

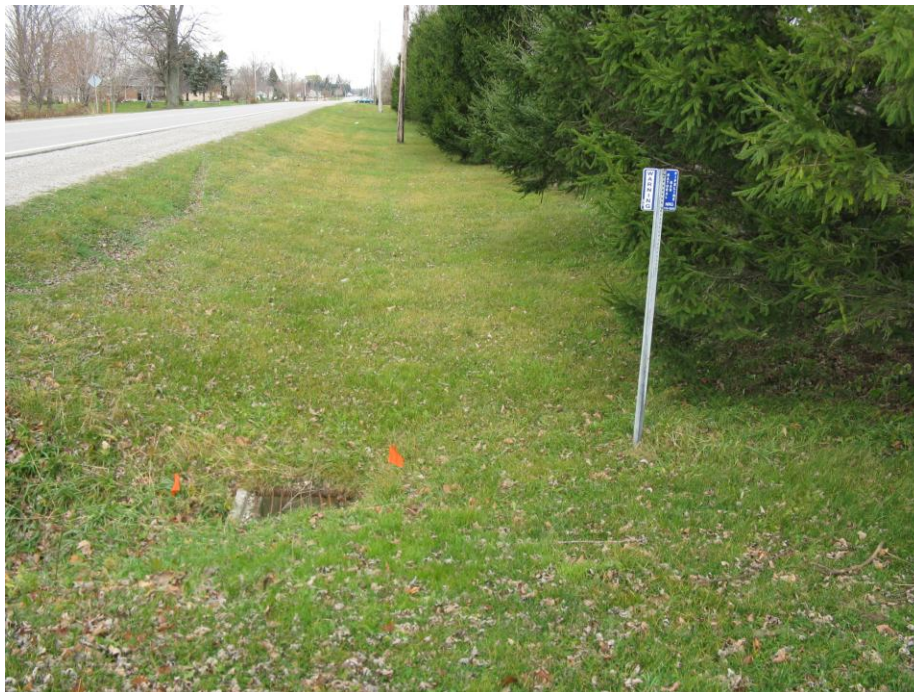
Image 12: Location of transmission line on the east side of Imperial Road, looking north (note ditching, sewer, gas pipeline)

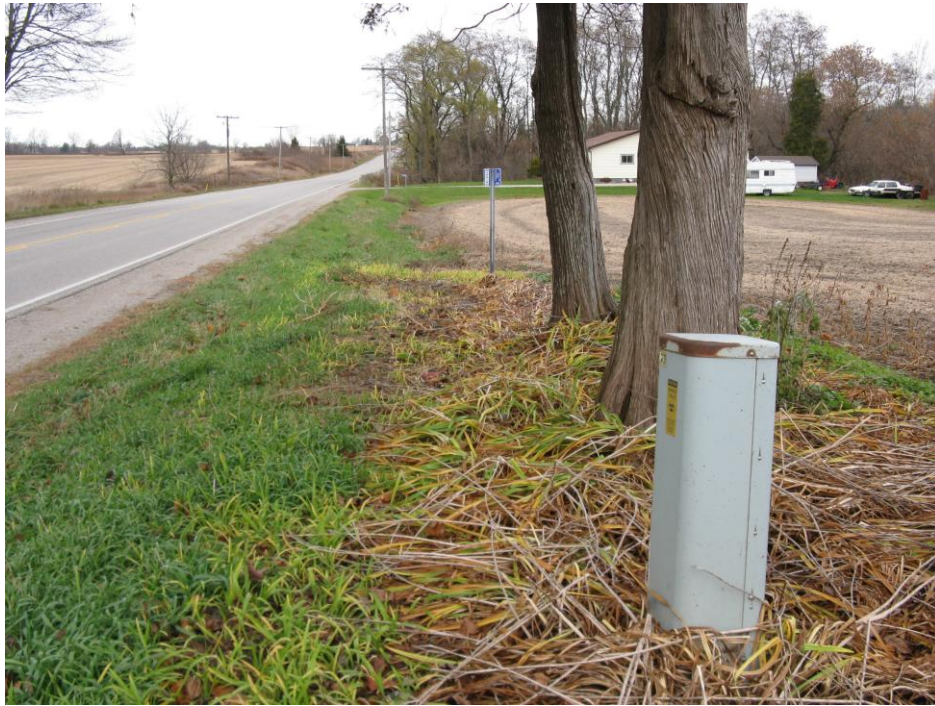
Image 13: Location of transmission line on the east side of Imperial Road, looking north (note ditching, telephone cable and gas pipeline)

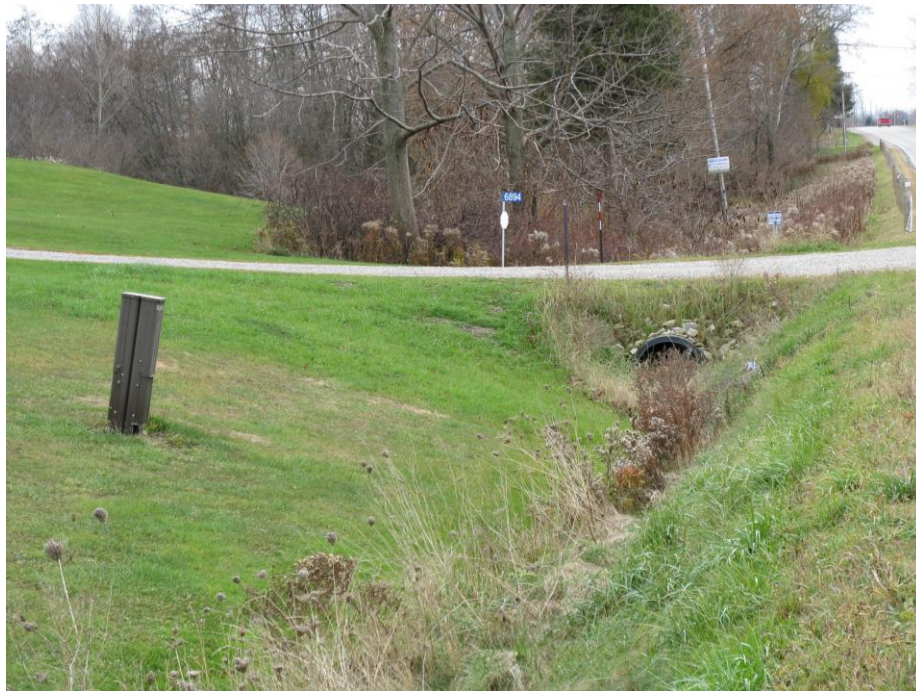
Image 14: Location of transmission line on the east side of Imperial Road, looking south at crossing of a tributary of Silver Creek (note ditching, fill slopes, telephone cable, gas pipeline)

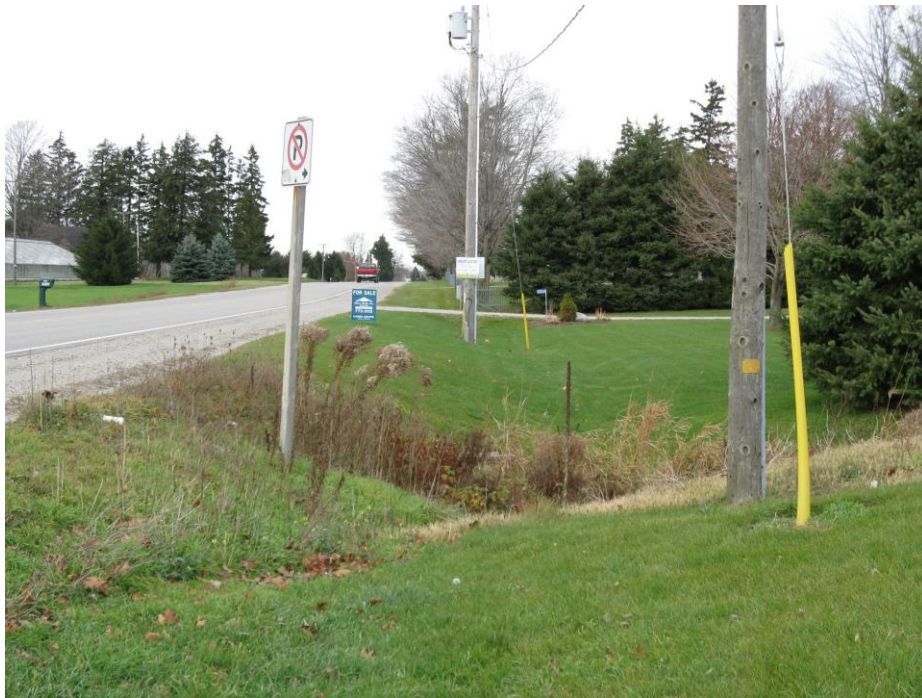
Image 15: Location of transmission line on the east side of Imperial Road, looking north (note ditching, fill slopes, telephone poles, gas pipeline)

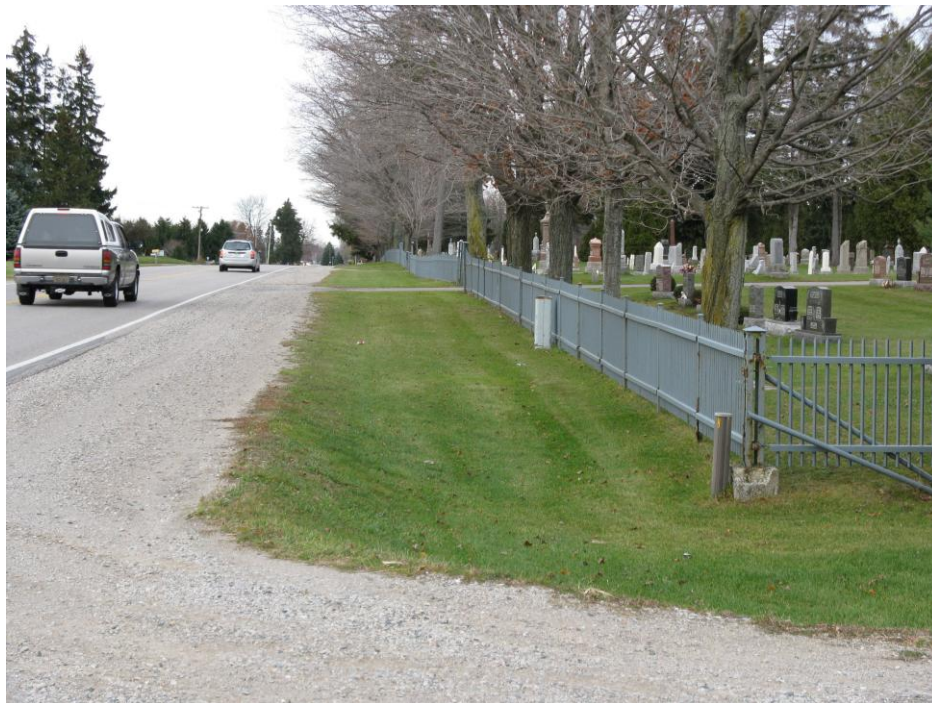
Image 16: Location of transmission line on the east side of Imperial Road, adjacent to cemetery, looking north (note ditching, fill slopes, telephone cable)

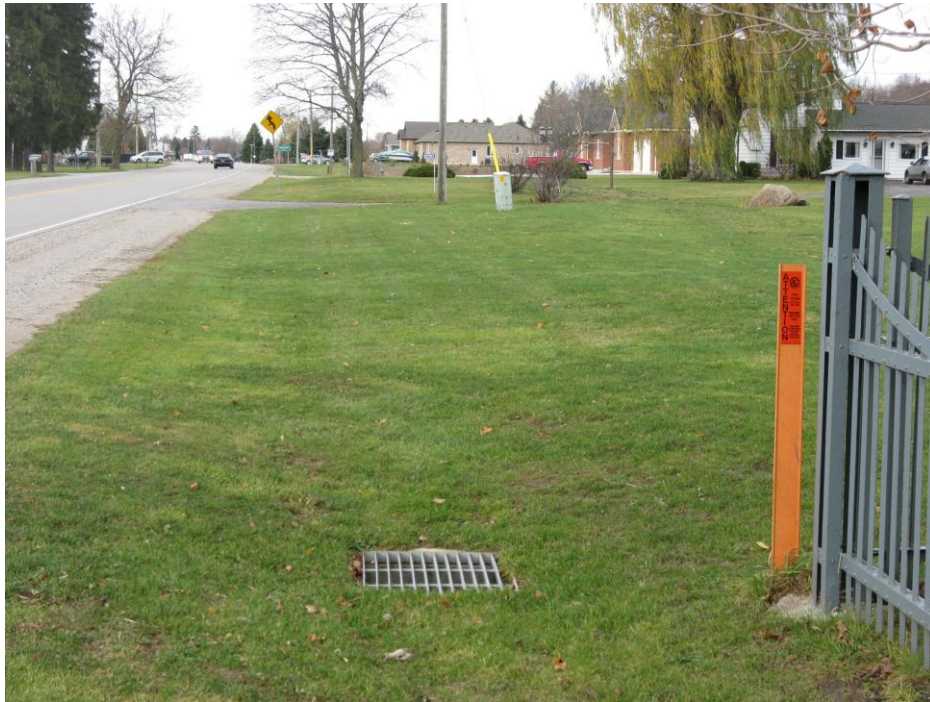
Image 17: Location of transmission line on the east side of Imperial Road, south of Tobacco Line, , looking north (note ditching, sewer, fibre optic cable)

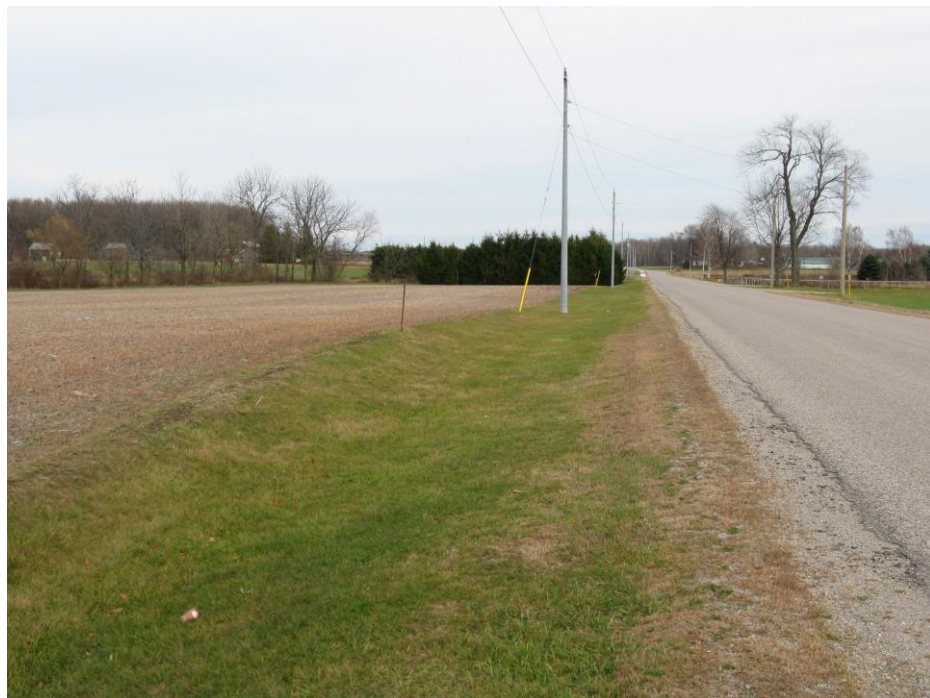
Image 18: Location of transmission line on the north side of Tobacco Line, looking east (note ditching, telephone poles)

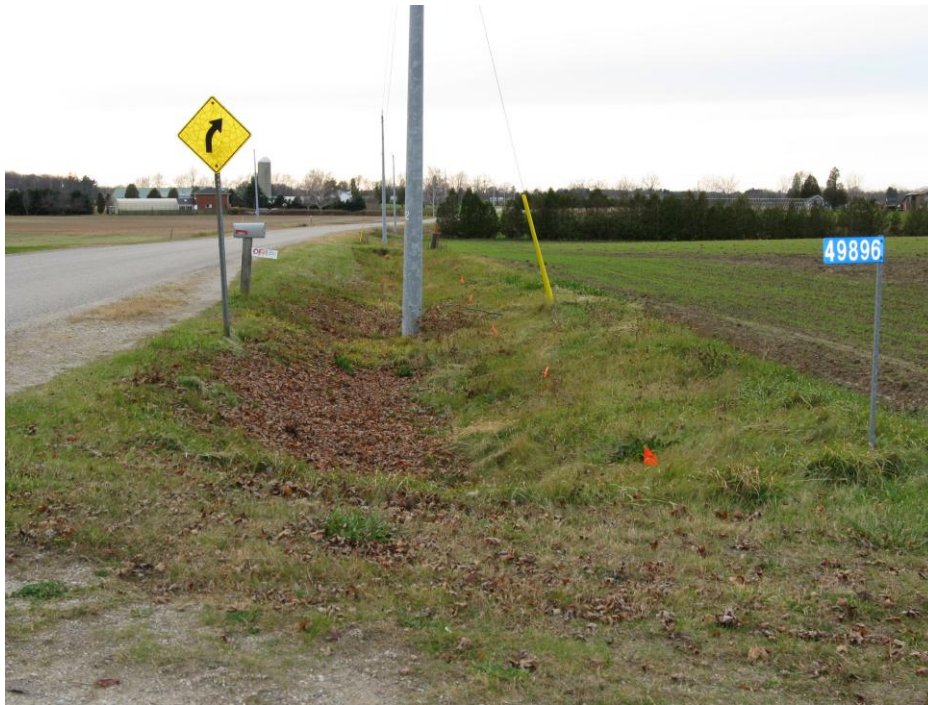
Image 19: Location of transmission line on the north side of Tobacco Line, looking west (note ditching, telephone poles and flagged buried cable)

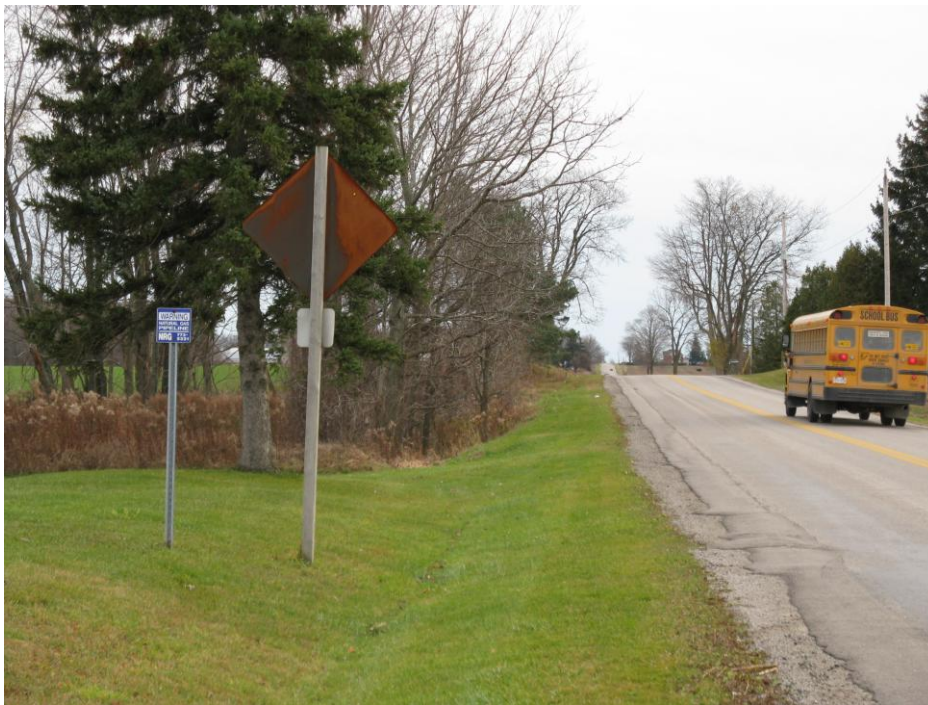
Image 20: Location of transmission line on the east side of Hacienda Road, looking south (note ditching and buried gas line)

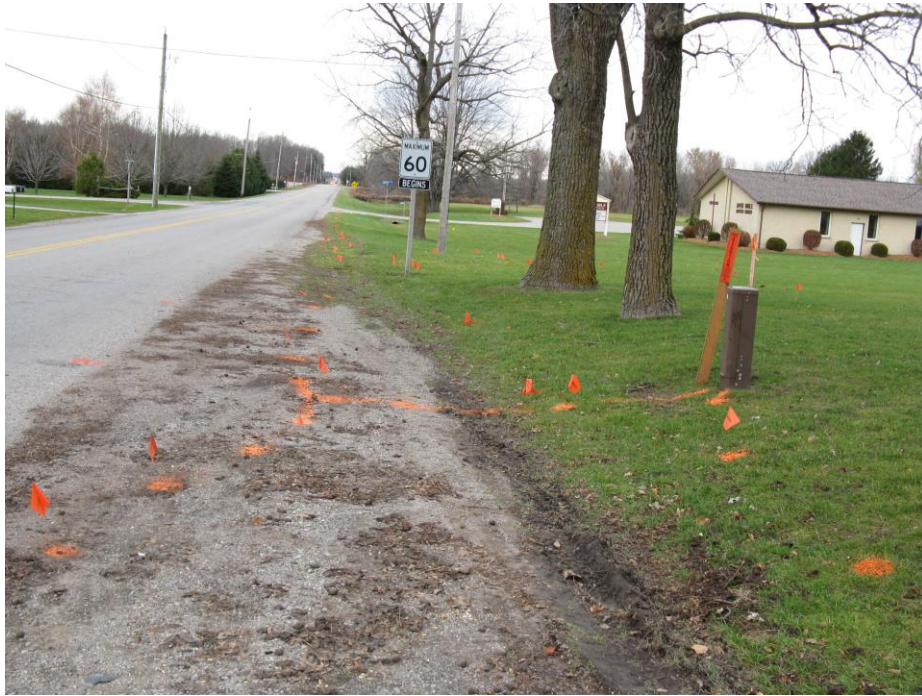
Image 21: Location of transmission line on the east side of Hacienda Road just north of Talbot Line, looking north (note marked buried telephone and fibre optic cables)

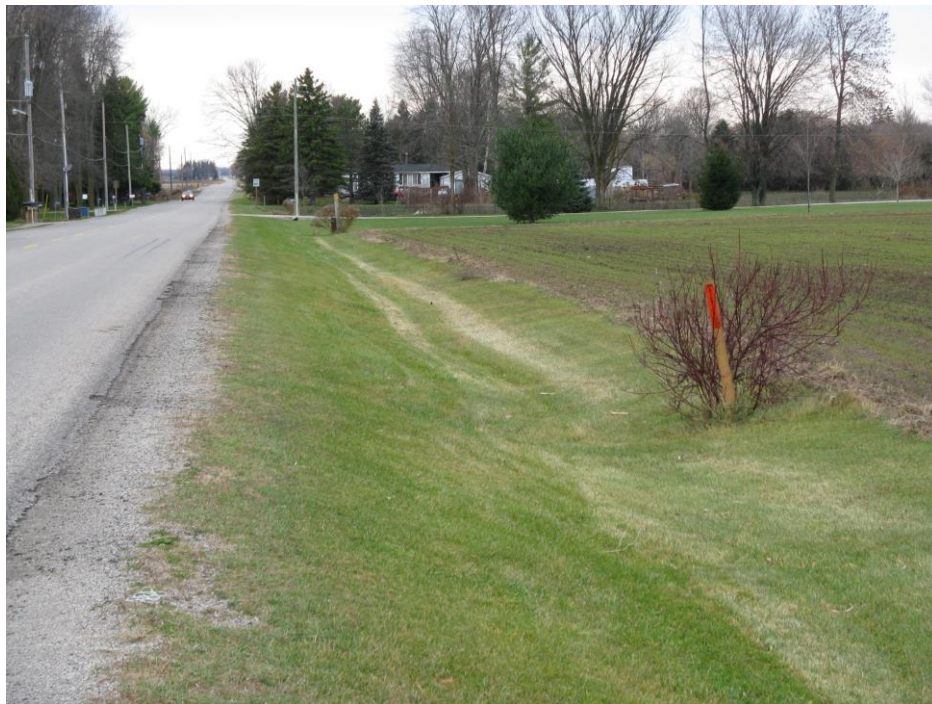
Image 22: Location of transmission line on the east side of Hacienda Road, looking north (note ditching and marked fibre optic cable)

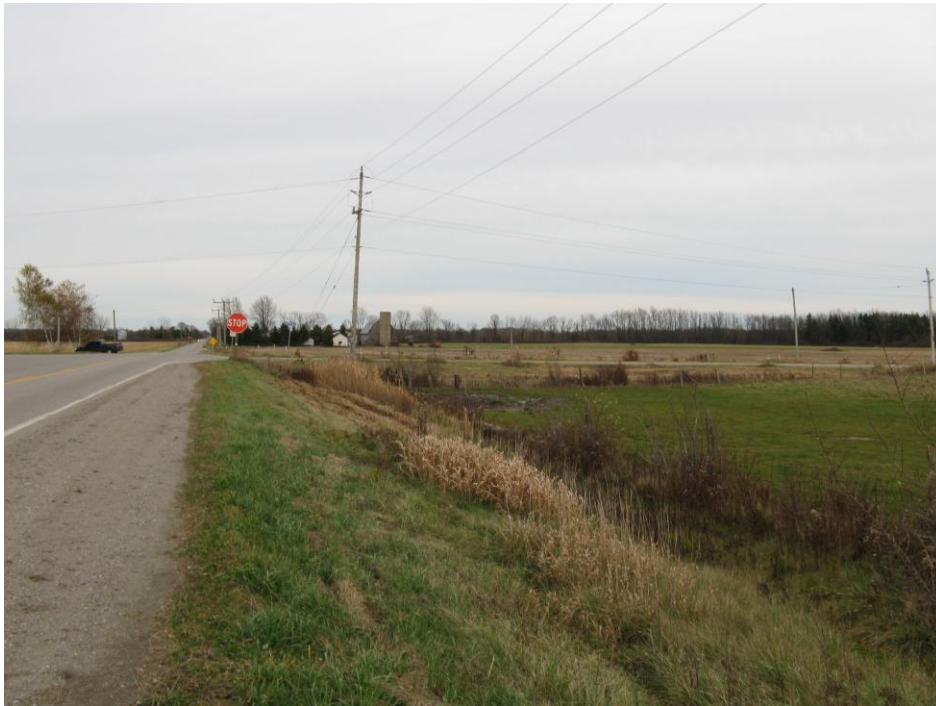
Image 23: Location of transmission line on the south side of Glencolin Line, looking east (note extensive fill slope and ditch)

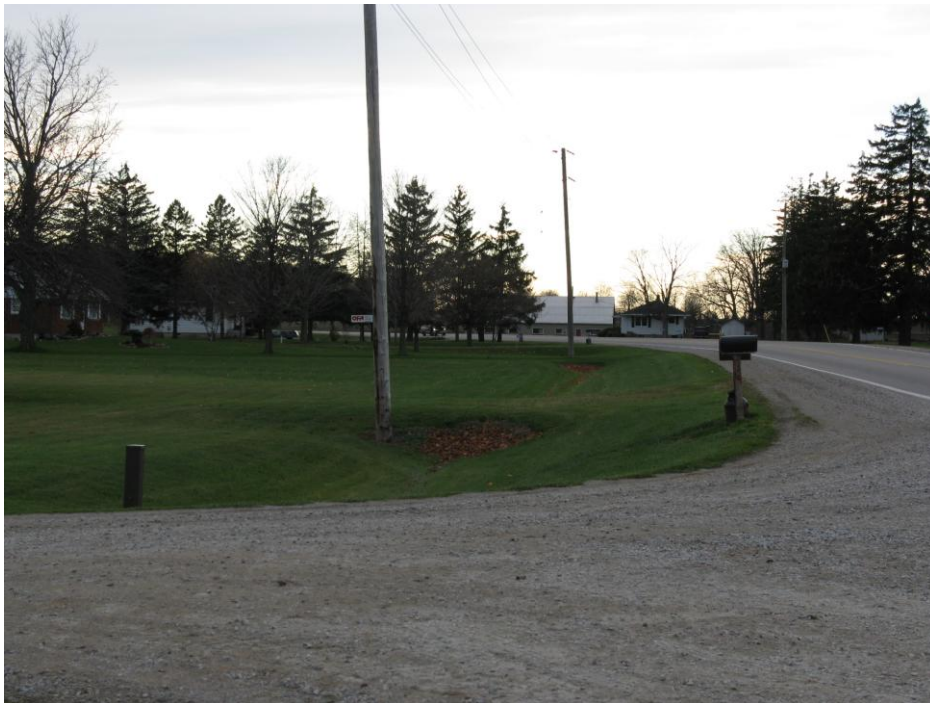
Image 24: Location of transmission line on the south side of Glencolin Line, looking west (note and ditching, driveways and landscaping)

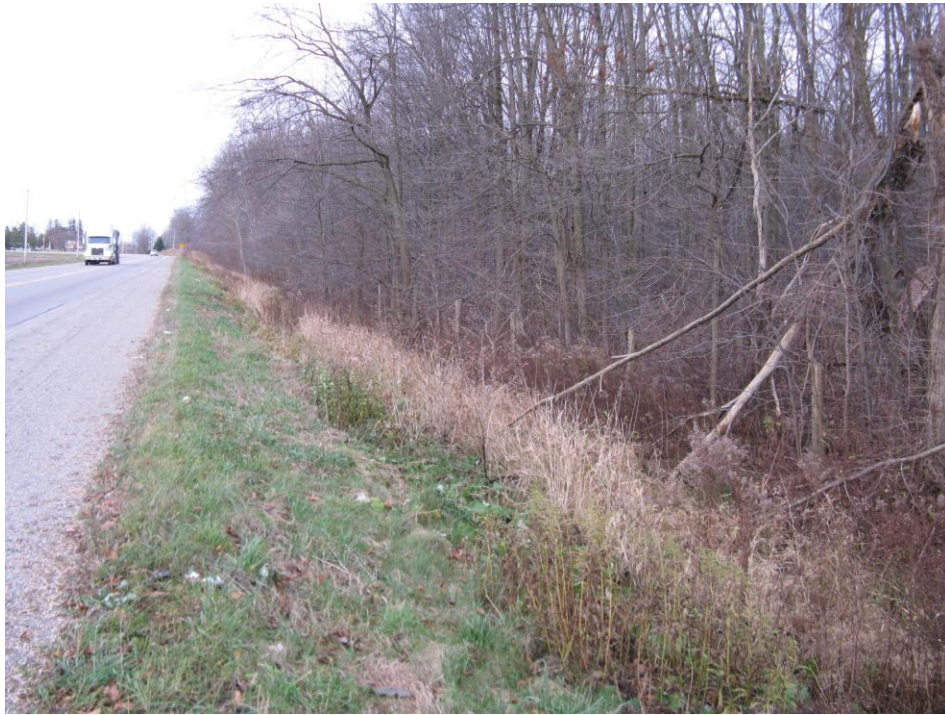
Image 25: Location of transmission line on the south side of Glencolin Line adjacent to woodlot, looking east (note extensive fill slope and ditch)

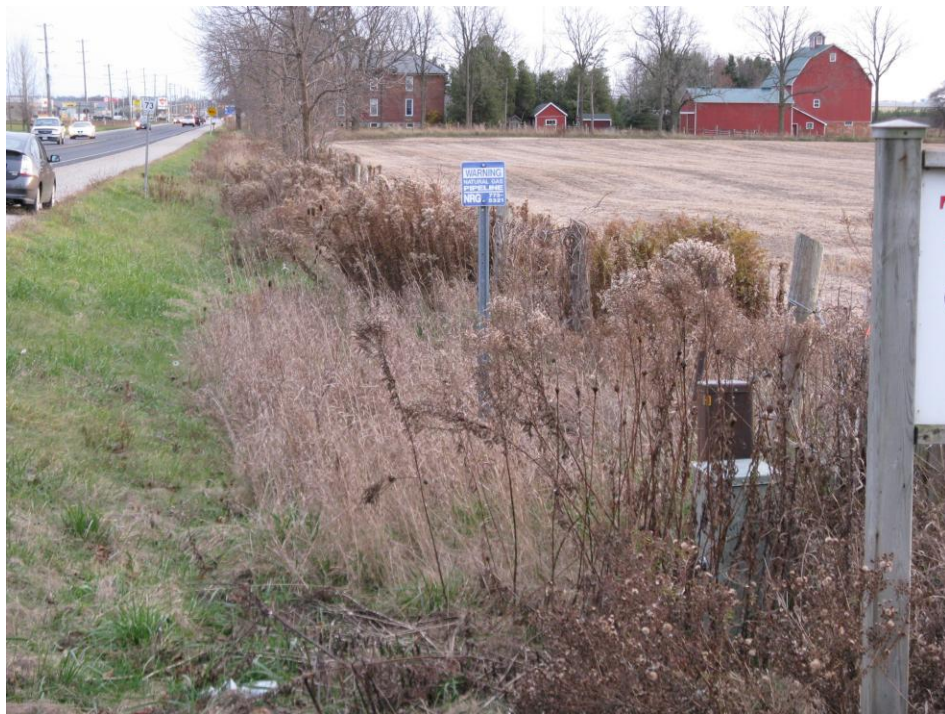
Image 26: Location of transmission line on the west side of Imperial Road just south of Glencolin Line, looking south (note fill slope, ditch, telephone cable and gas pipeline)

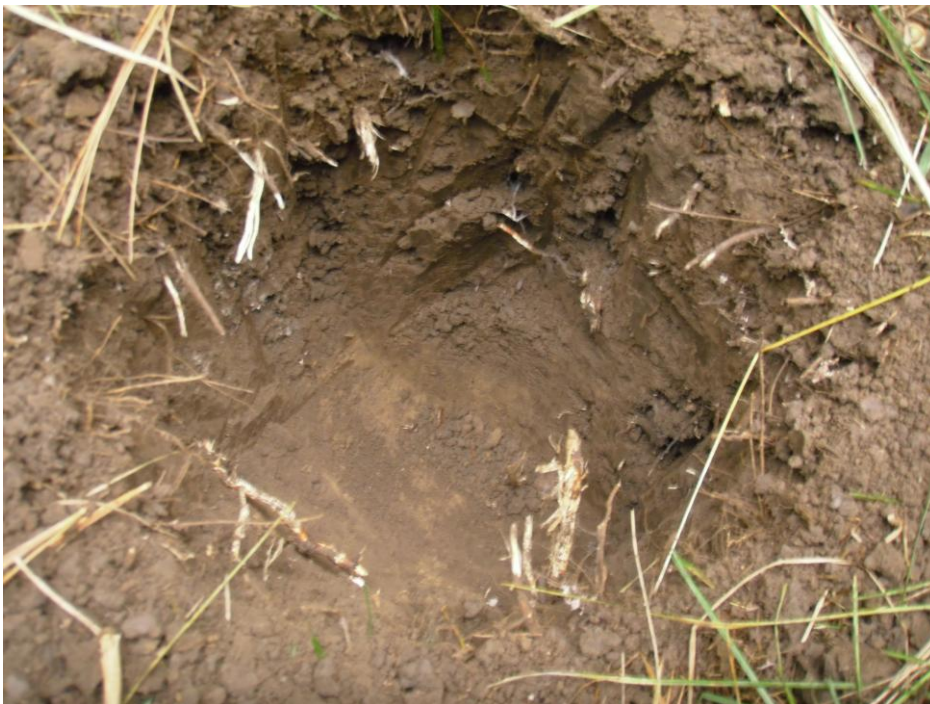
Image 32: Typical test pit on the substation property
